**Notes on broken Ring Heater Element D1002538-v4 SN-210:**  
Due to Post-Installation Adjustment with Pliers  
(14-March-2014)

M. Jacobson  
18-March-2014

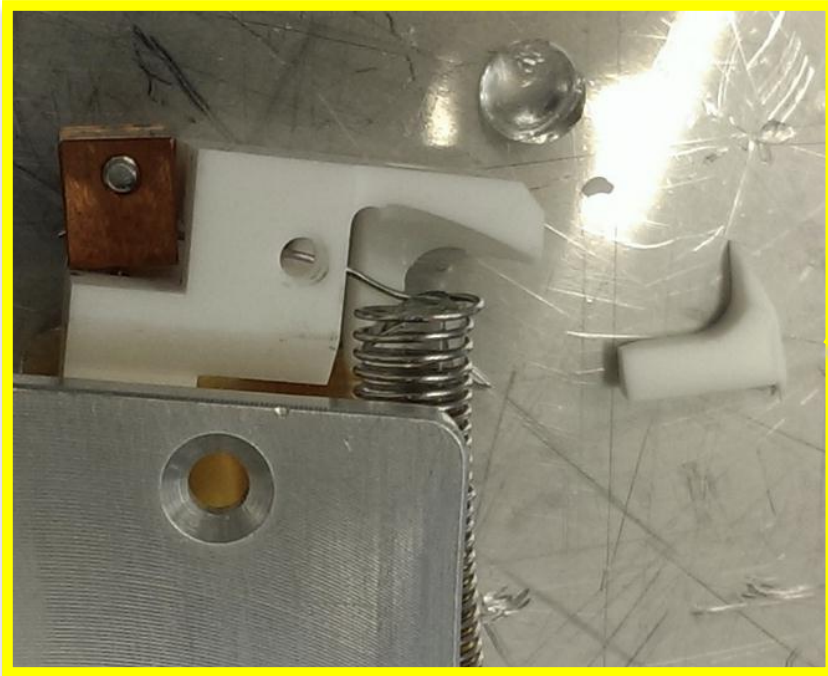
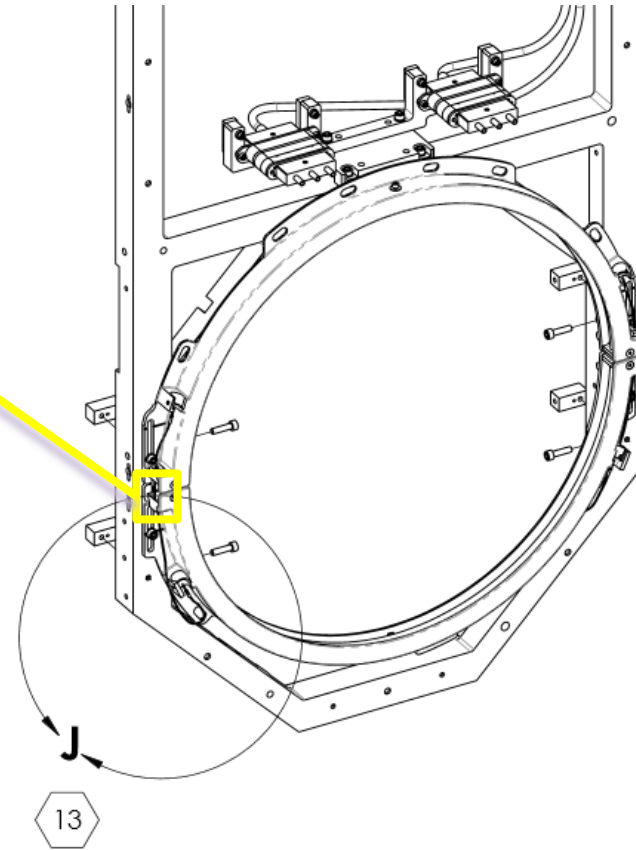
# Photos of broken pieces vs. Intended assembly

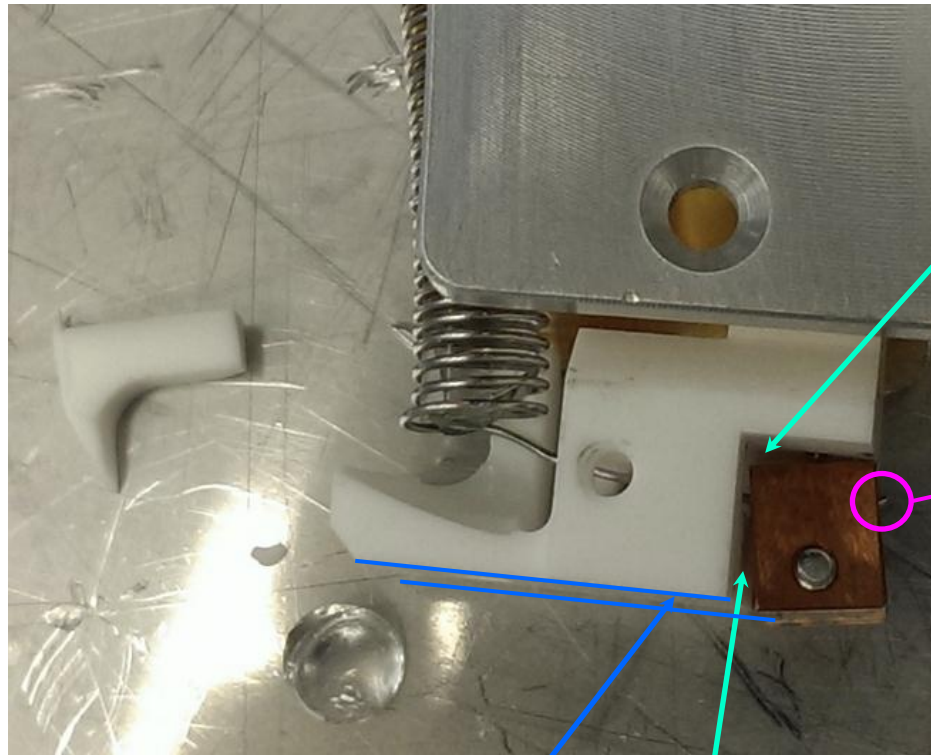
The base plane of the macor retainer is intended to be flush with the base plane of the macor retainer of the adjacent (upper) RH assembly.

These gaps were noticed by SUS, causing the copper pieces (D1200560 & D1200561) to extend beyond the base plane of the adjacent macor retainer (D1002544)

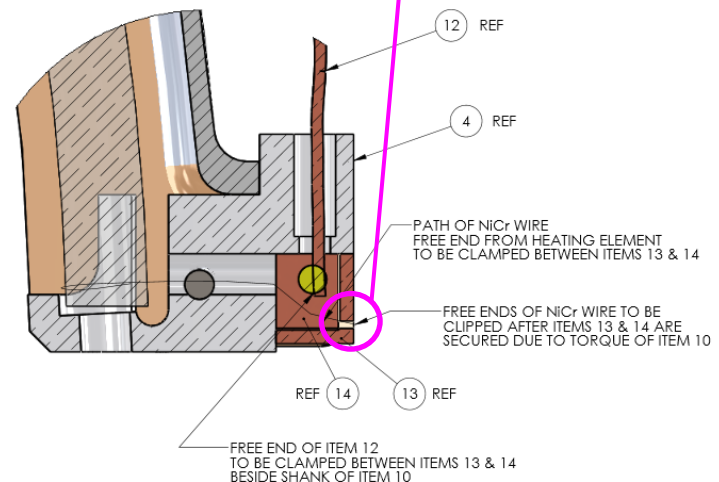
Apparently, pliers were used to “tug” at the pair of copper clamping parts.  
**NOTE:**  
This protruding free end of NiCr wire is not seated properly between the two copper clamping plates. Hence, it would not have been possible to “tug” the pieces in any way that would have reduced the gaps.
