# Issue History

Tuesday, June 27, 2017 17:07

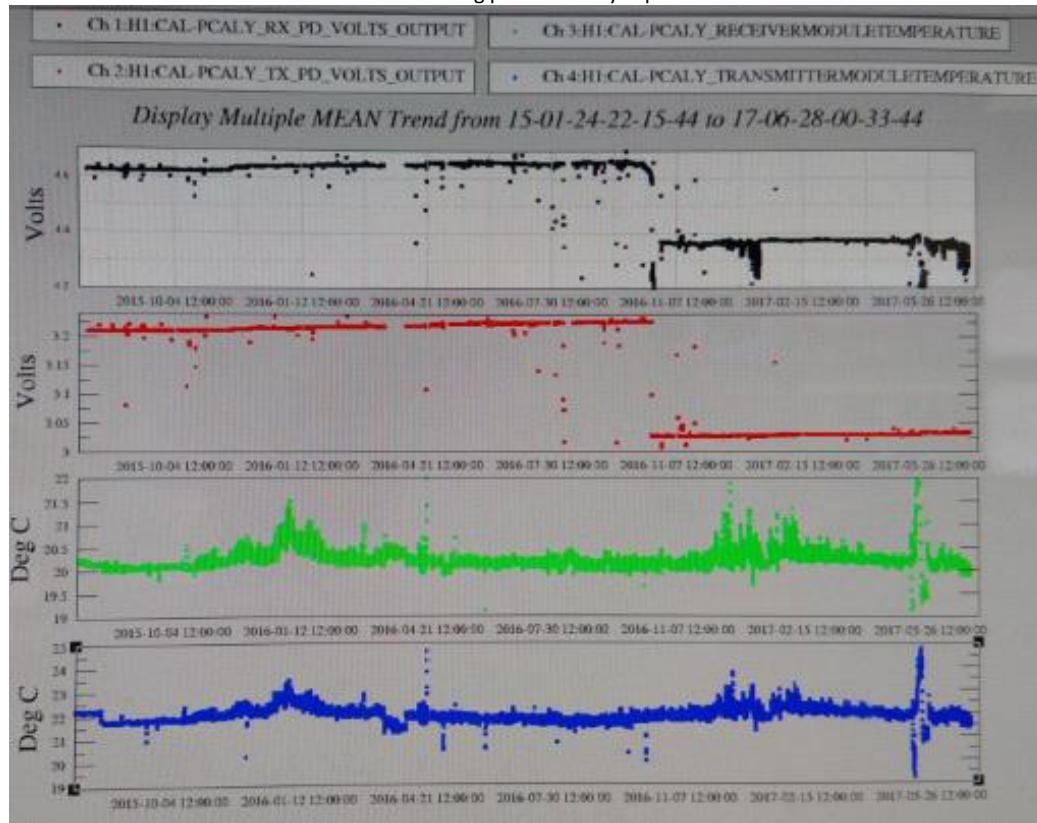
So some step change in PD levels around October of 2016; perhaps recalibration?

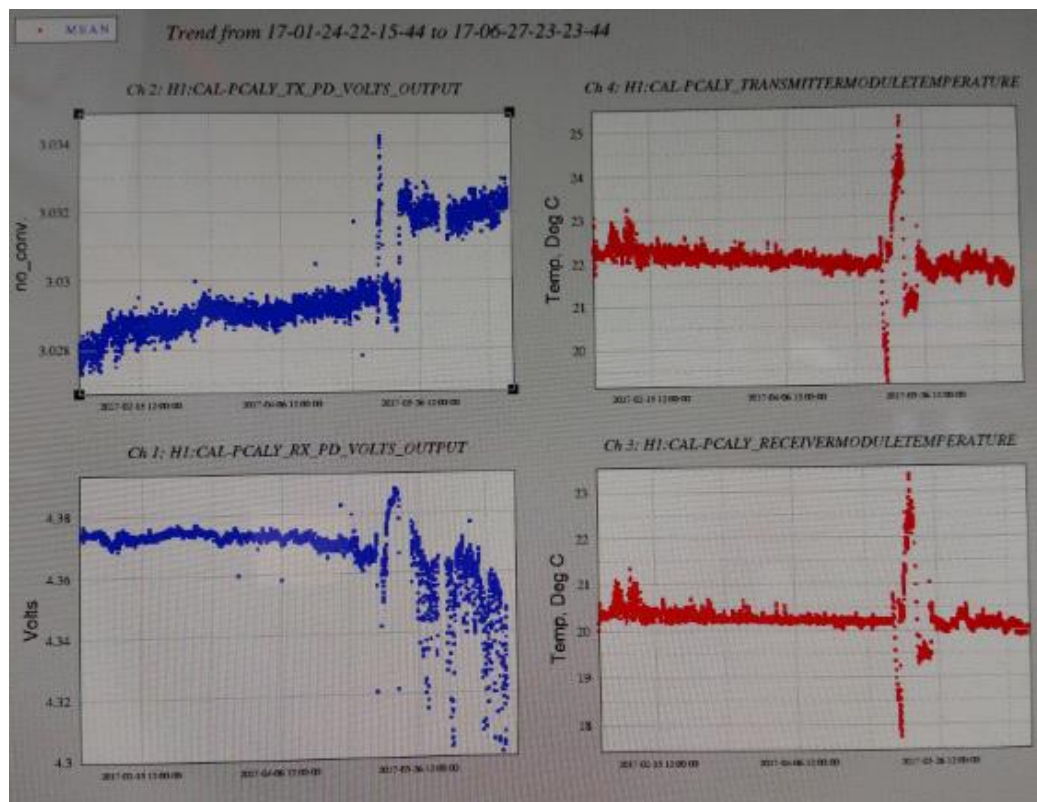
Looks like both Tx and Rx also received some adjustment during maintenance tasks following vent in May (will have to check aLOGs) but Rx sees that ugly variation afterward (will have to produce an X-Y

plot of Temp v PD volts after that). Just eyeballing it, that variation is roughly  $\sim 0.07$  volts, or  $0.07 / 4.38 = 0.016 = \sim 1.2\%$  variation. Tx varied about  $0.002 / 3.032 = 0.0007 = \sim 0.07\%$  percent in the same period.

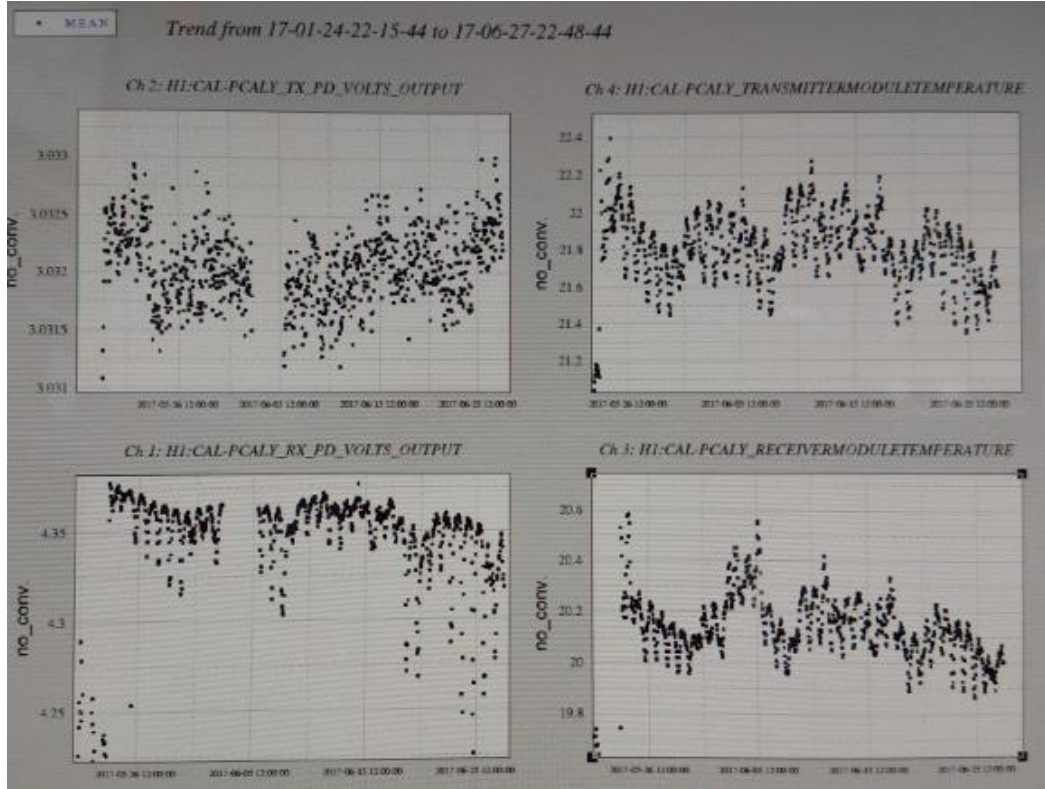
At first glance, there is some correlation, but will need to dig deeper to confirm. If true, onto next investigation stage.

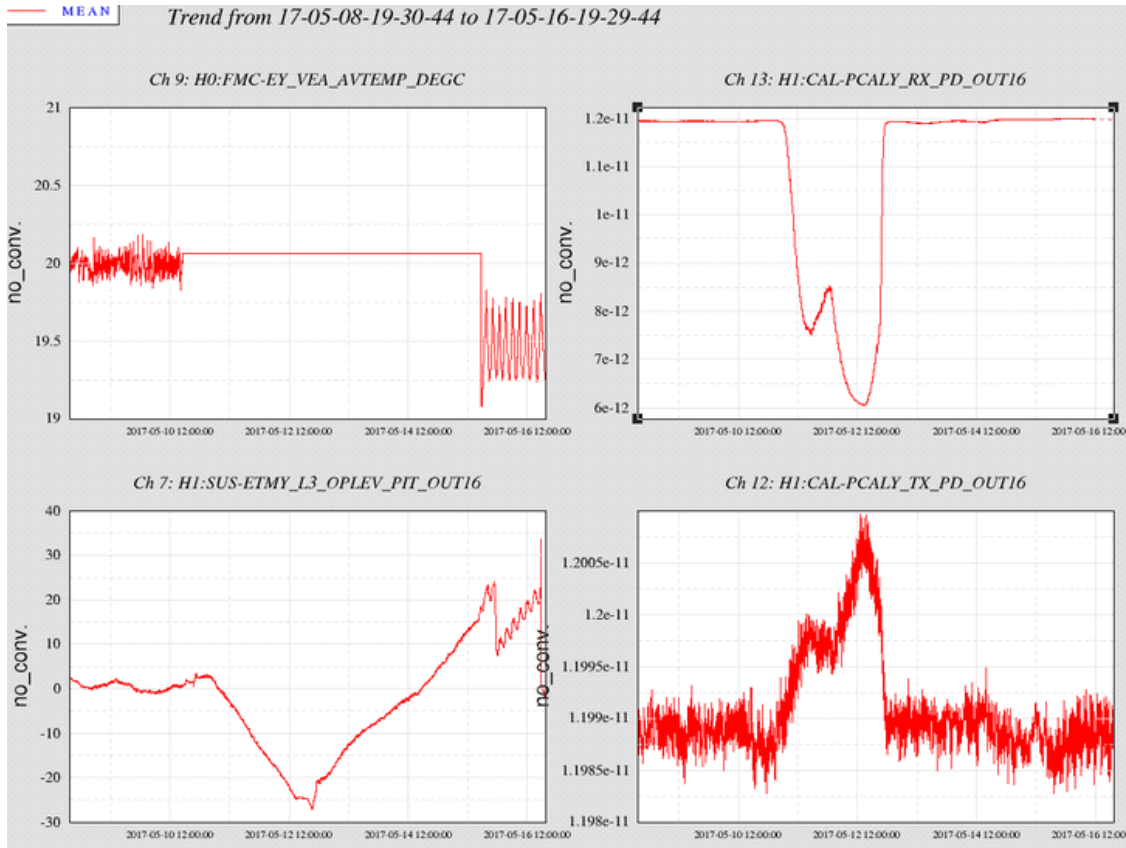
It also reports the first major change in Pcal PD outputs; per Jeff: "**Also note that PCAL Y sees a substantial effect of the large temperature excursions seen in the VEA during the upgrade as well, indicating that there is still some temperature sensitivity left in the system, like what was seen back in January (see, e.g. [LHO aLOG 34153](#)).**

**The gross clipping has gone away since the temperature has \*mostly\* recovered, but -- presumably because of the 0.5 deg C difference in static temperature, the RXPD is reporting 0.2% higher displacement than before the HVAC upgrade. Further, one can see the ~3 hour oscillation in the RX**

Clear interaction shown, though I'll want to look at ratio and sum of Rx and Tx PD's of the latter portion.

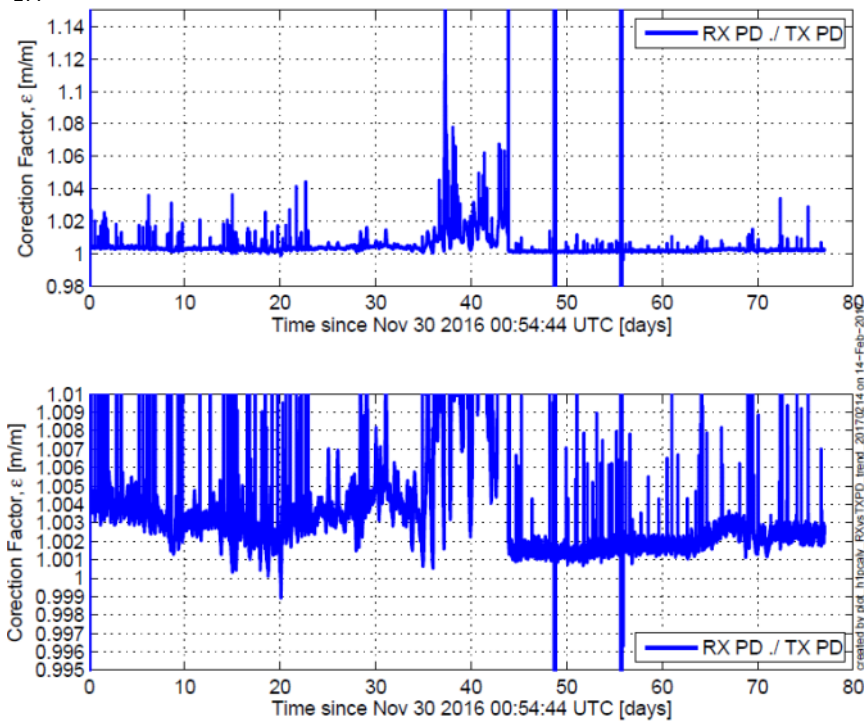
In this case, the ratio is positive because it describes the ratio of "reported displacement," which is inverse to PD voltage. Ratio variations are ~4% before ~Jan 9 and ~2% after.

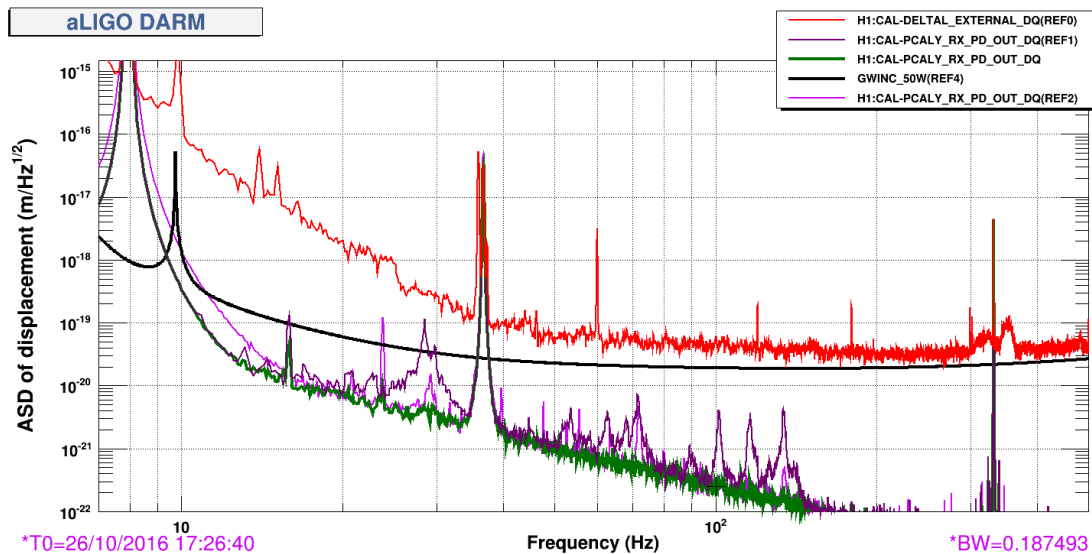
aLOG 33108 points to both the investigation aLOG 33187 and the initial identification back in October (per Jeff: **Identified in LHO aLOG 30827; Solved in LHO aLOG 30877**). 33108 from Jan 9 mentions repeat of previous indications in Rx PD's ASD and time series:

Purple is ASD of Rx RD Out from Jan 9, pink is from last October (post previous fix, to be explored in other aLOGs). Time series below indicates that assumed "clipping" returns after IFO resumed operations on Jan 4:

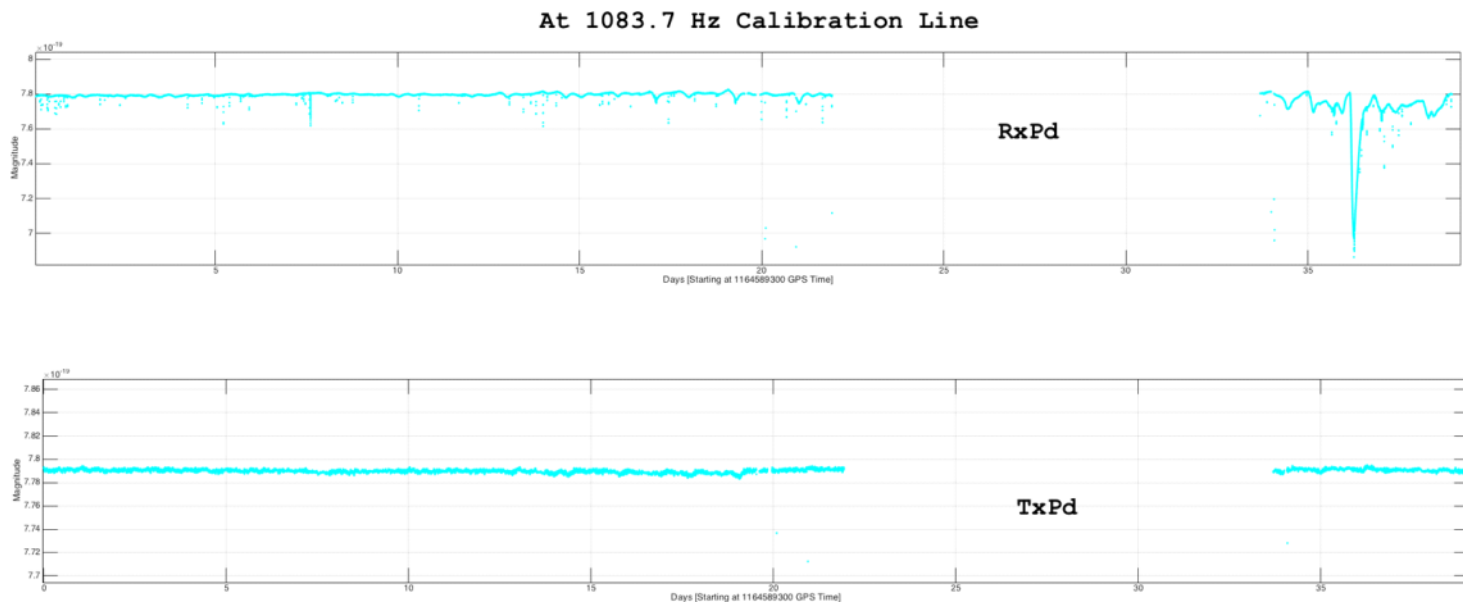
As part of that aLOG, Sudarshan reported a change of magnitude of the ~1.08 kHz calibration line on Rx after the most recent "break" before January (the below is Dec 1 to Jan 8):

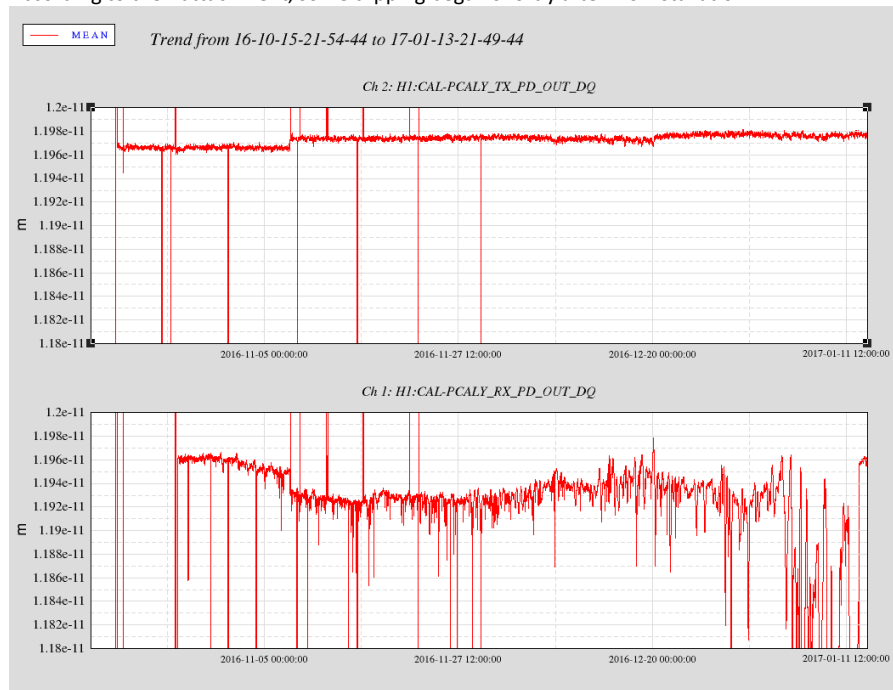
Since aLOG 33187 is supposed to be the "solution" to the above discovery, it reports that Travis/Evan felt that clipping was occurring at "newly installed alignment irises" installed during the final two aLOGs in this investigation (two oldest). They proposed to move said irises instead of moving the Tx steering mirrors but I'll need to search the logs to see if this was done. They hypothesized that either Tx module steering mirrors or in-vac periscope mirrors may be drifting but they don't know why. According to their attachment, some clipping began shortly after iris installation:

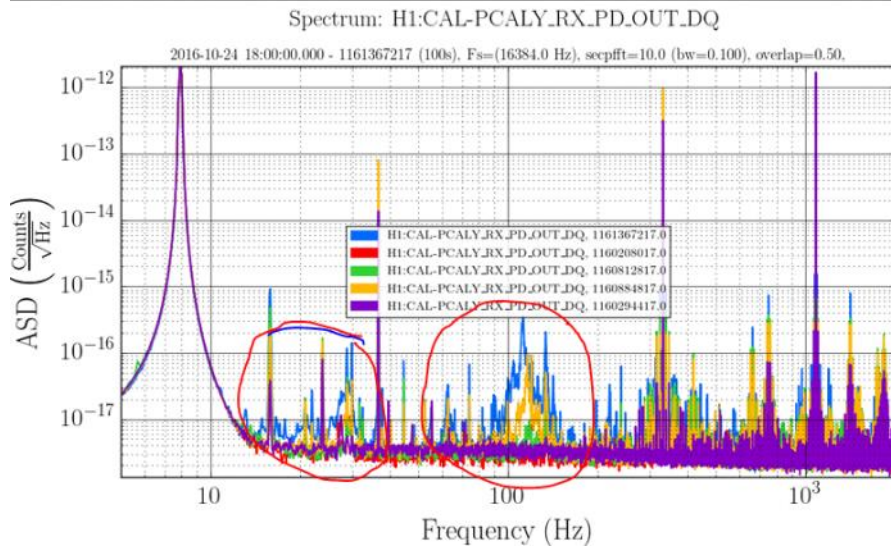
The *original* aLOG reporting clipping goes all the way back to 24-Oct in log 30827. Evan noticed ASD peak growth for the 15-30 Hz and 90-140 Hz regions of the Rx when the Tx was unchanging:

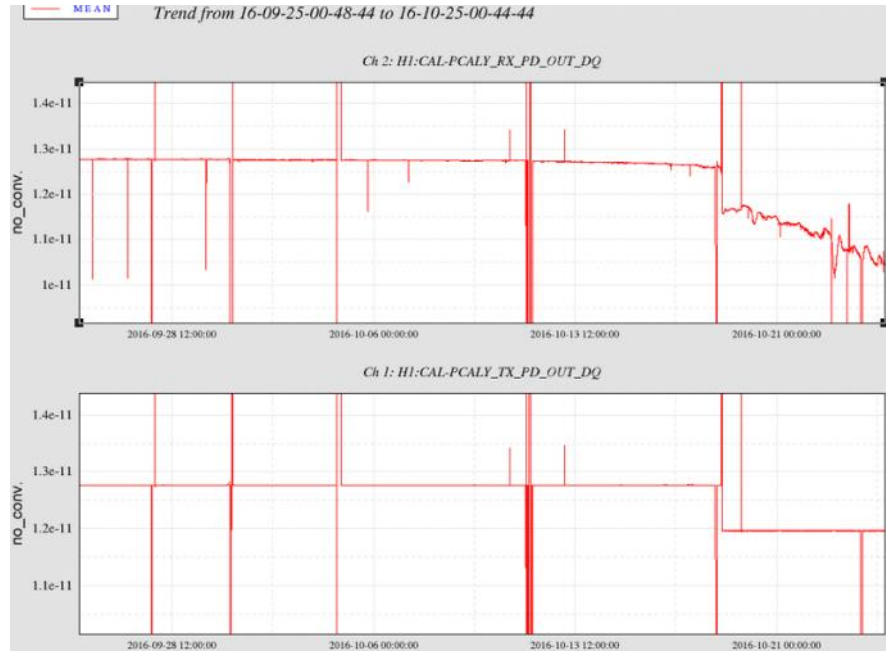
Their best clue at the time was that these peaks seemed to start changing after Pcal beam realignment in mid-October, though they didn't reference an aLOG for this (they quote Oct 18). They show a time series to demonstrate:

After the large step, they saw a **monotonic decrease of  $(1.15 - 1.05) / 1.15 = 0.087 = 0.087 = \sim 9\%$** .

To my eyes, some curvature of the output begins before the large step. I'm not entirely convinced that this was the origin of the power loss but realignment may have contributed further to power loss, or there is some physical clipping combined with another issue.

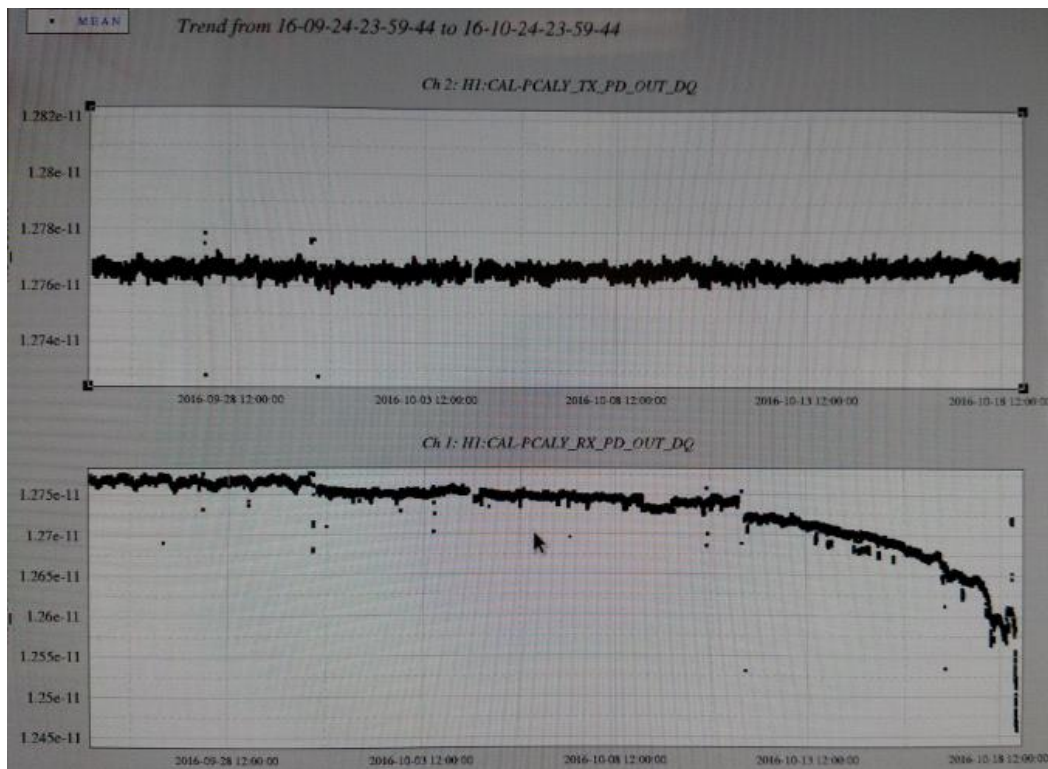
Confirmed, there is definitely earlier curvature:

Looks to be about a week before this date of October 18. The above shows  $(1.27 - 1.255) / 1.27 = 0.0118$  = a ~1.2% drop in one week, monotonically (not counting the last vertical drop). How does this compare to the range of the last few months?

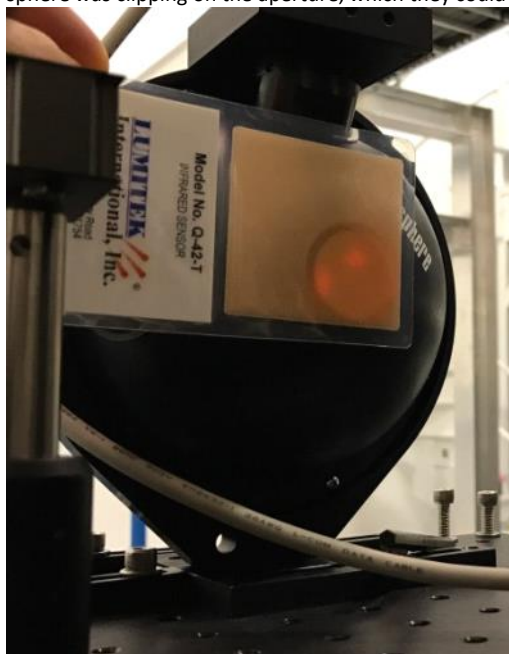
So aLOG [30877](#) describes the beam realignment. They state that the outer beam at the Rx integrating sphere was clipping on the aperture, which they could see with infrared cards.

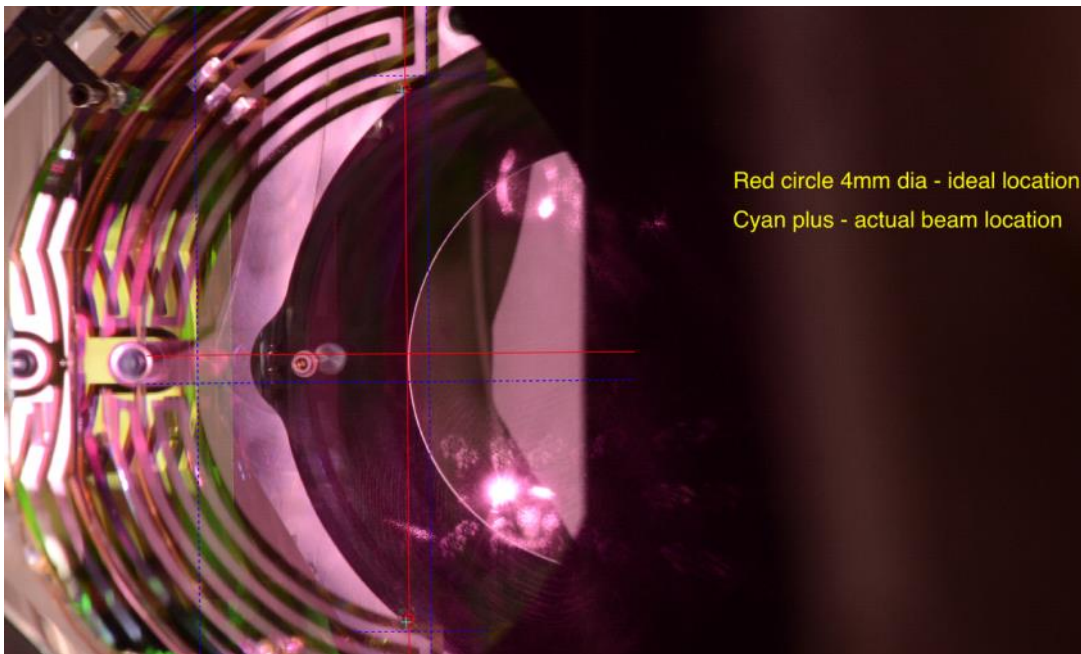
They also took images showing beam movement on the ETM, thus confirming that the beam had moved but not the ETM.

The following measurements were made: the upper dot was left 1.5mm and up 1.8mm, and the lower beam was left 6.9mm and down 2.5mm; post alignment, they changed this to the upper beam being left 1.4mm and down 0.9mm and the lower beam being left 1.3mm and down 1.4mm (above image). They then installed "apertures" (more irises?) at Tx output and Rx input.
