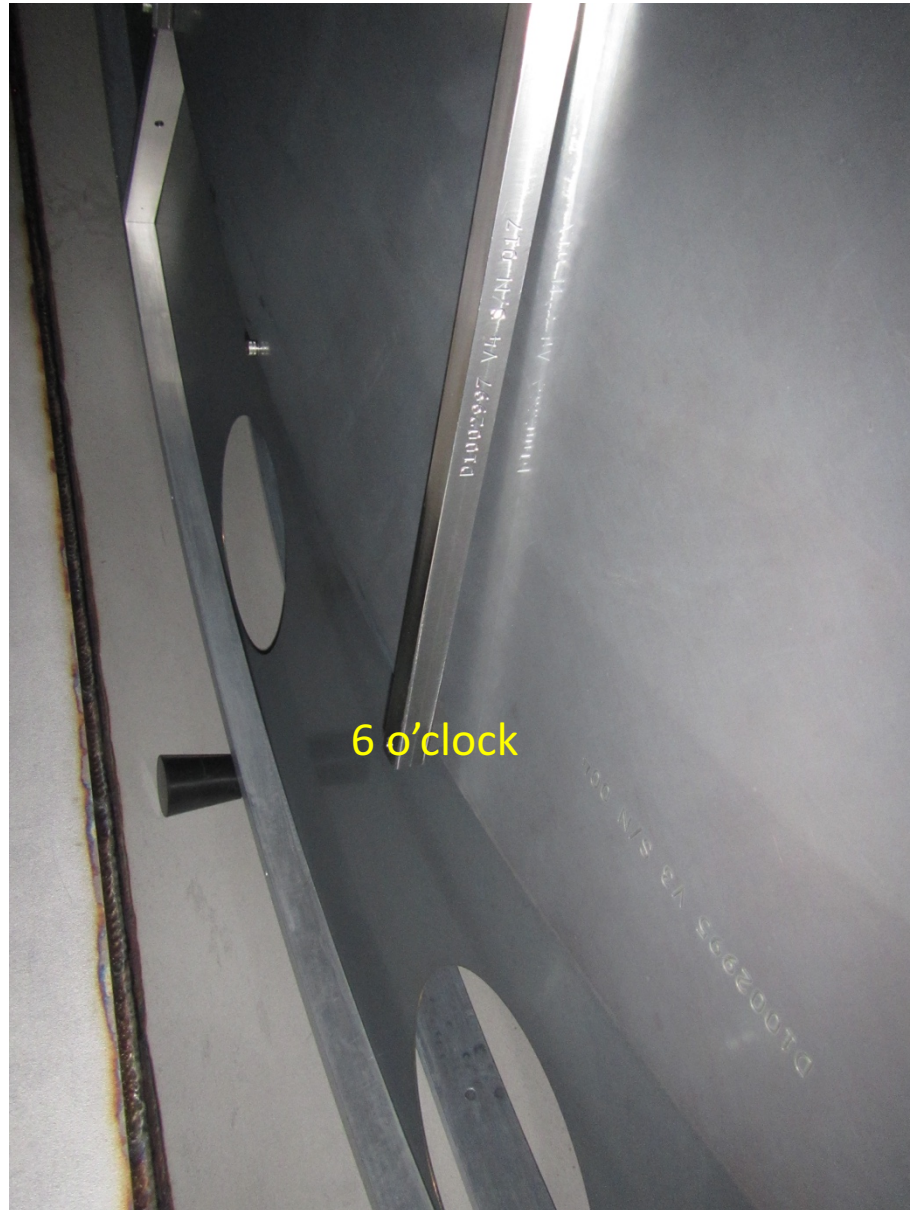
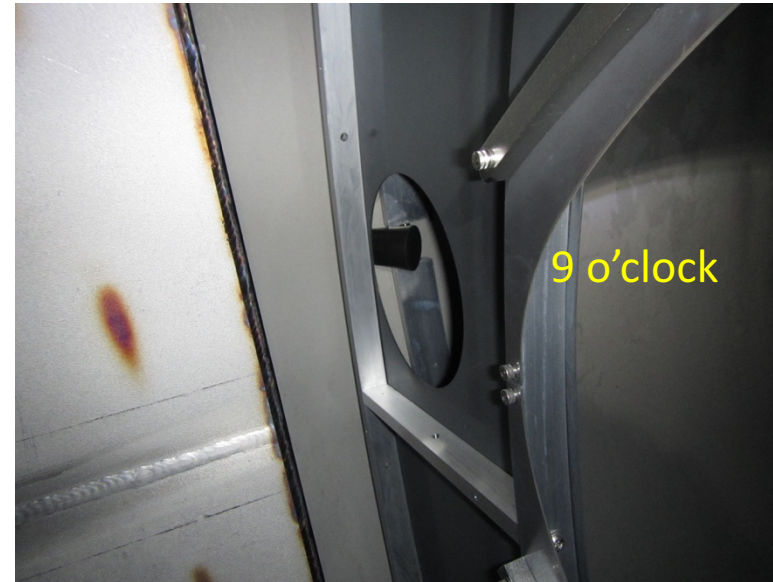
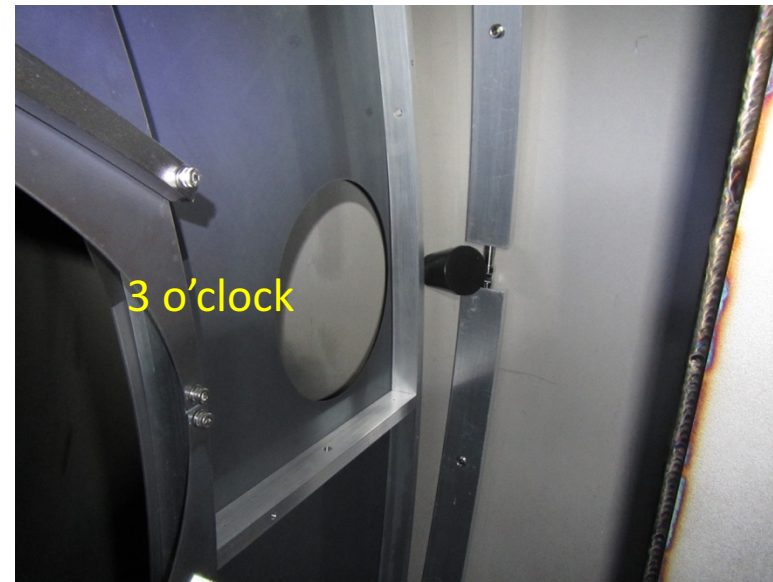
Damping corks added to MCA2, viewed from HAM3 side

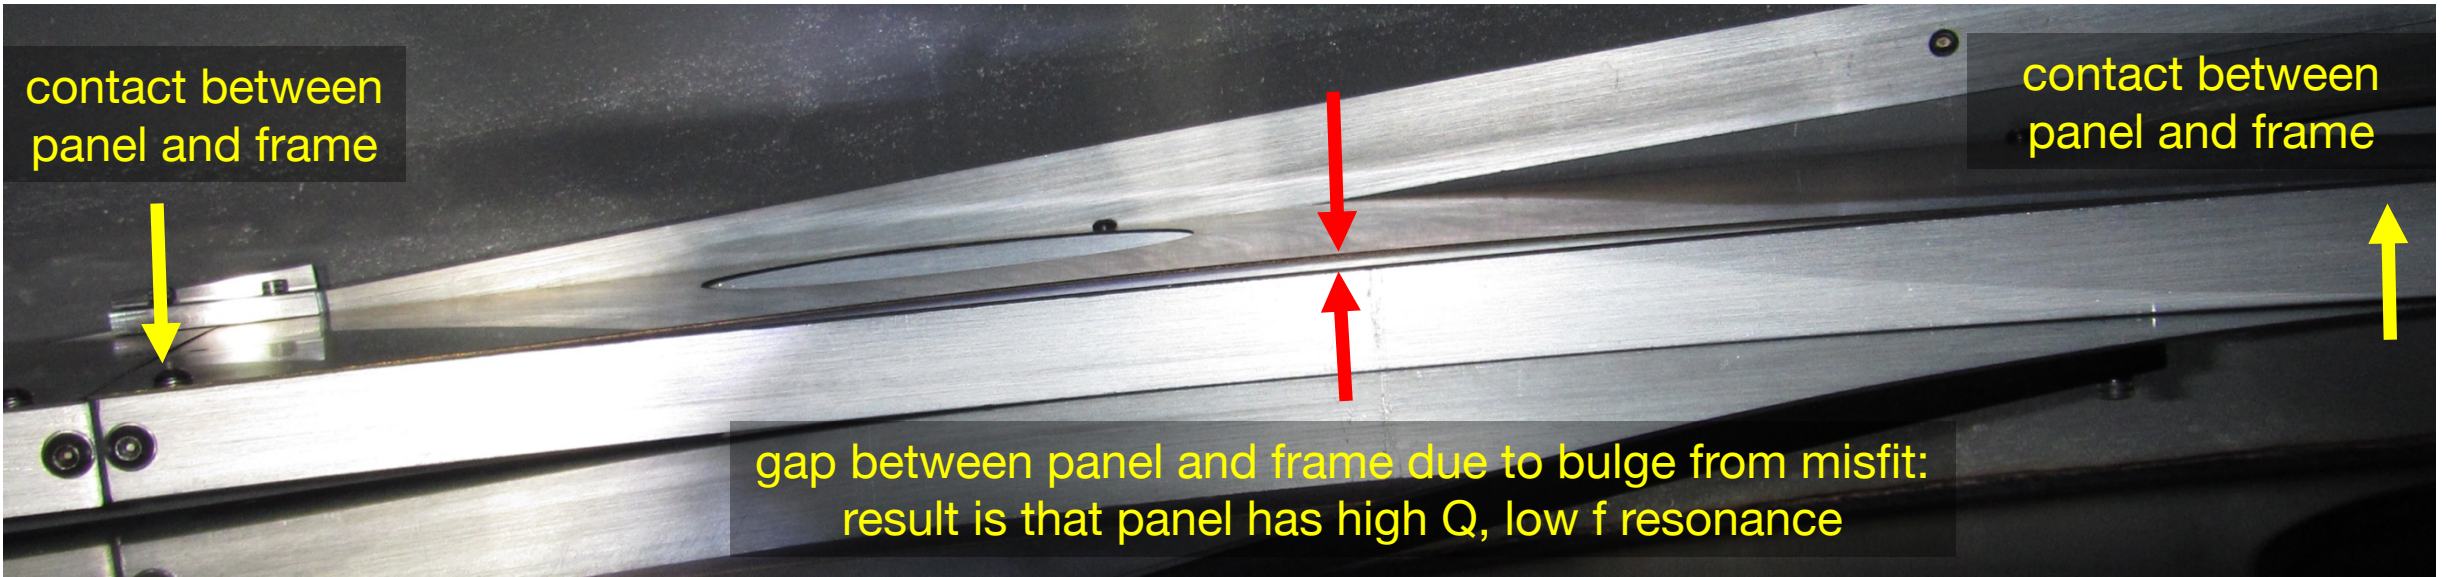
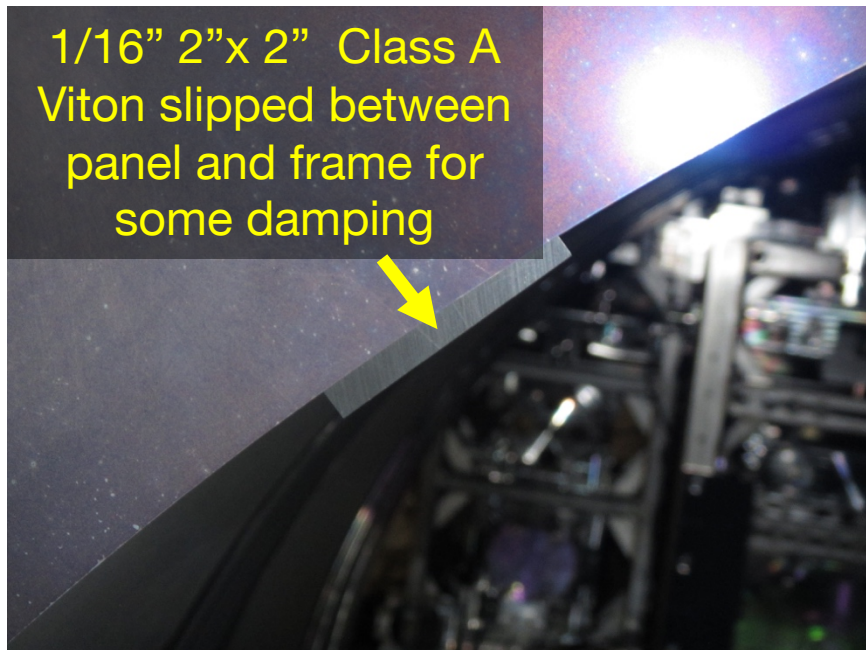
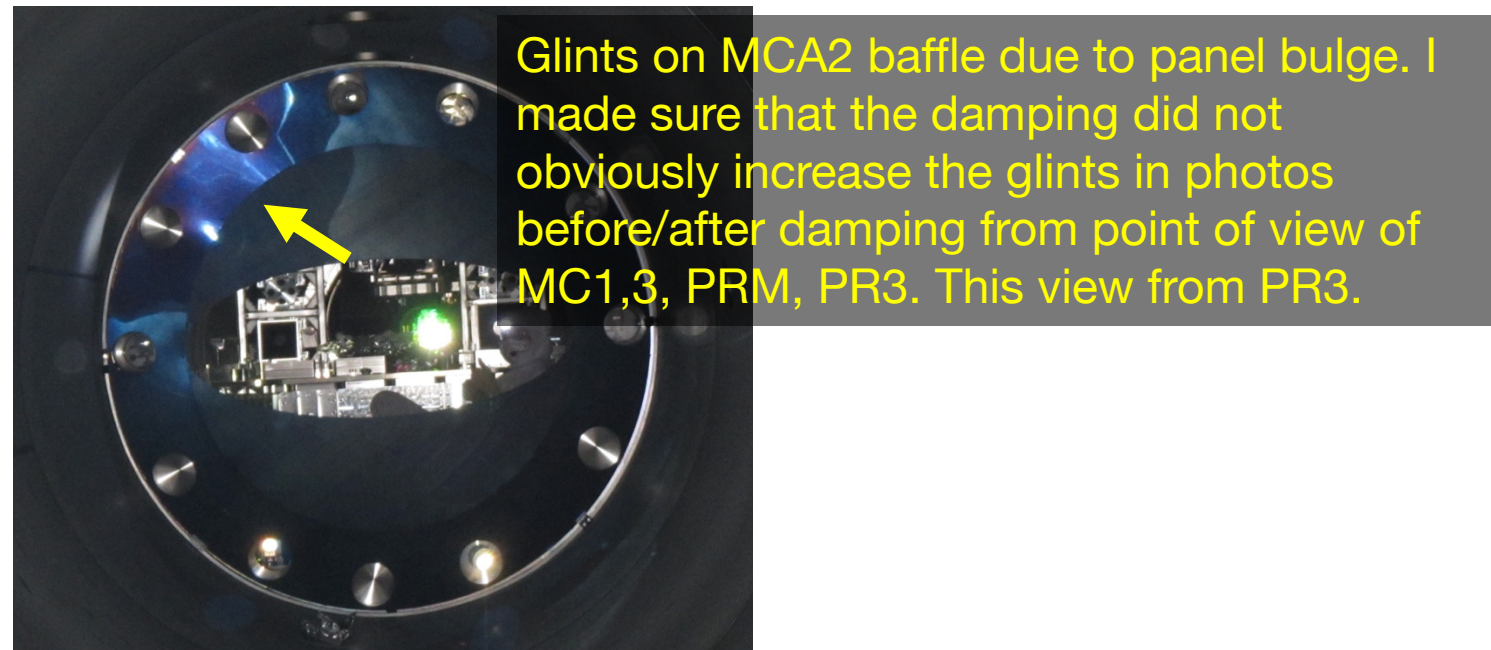
Damping was added to panel bulge gaps

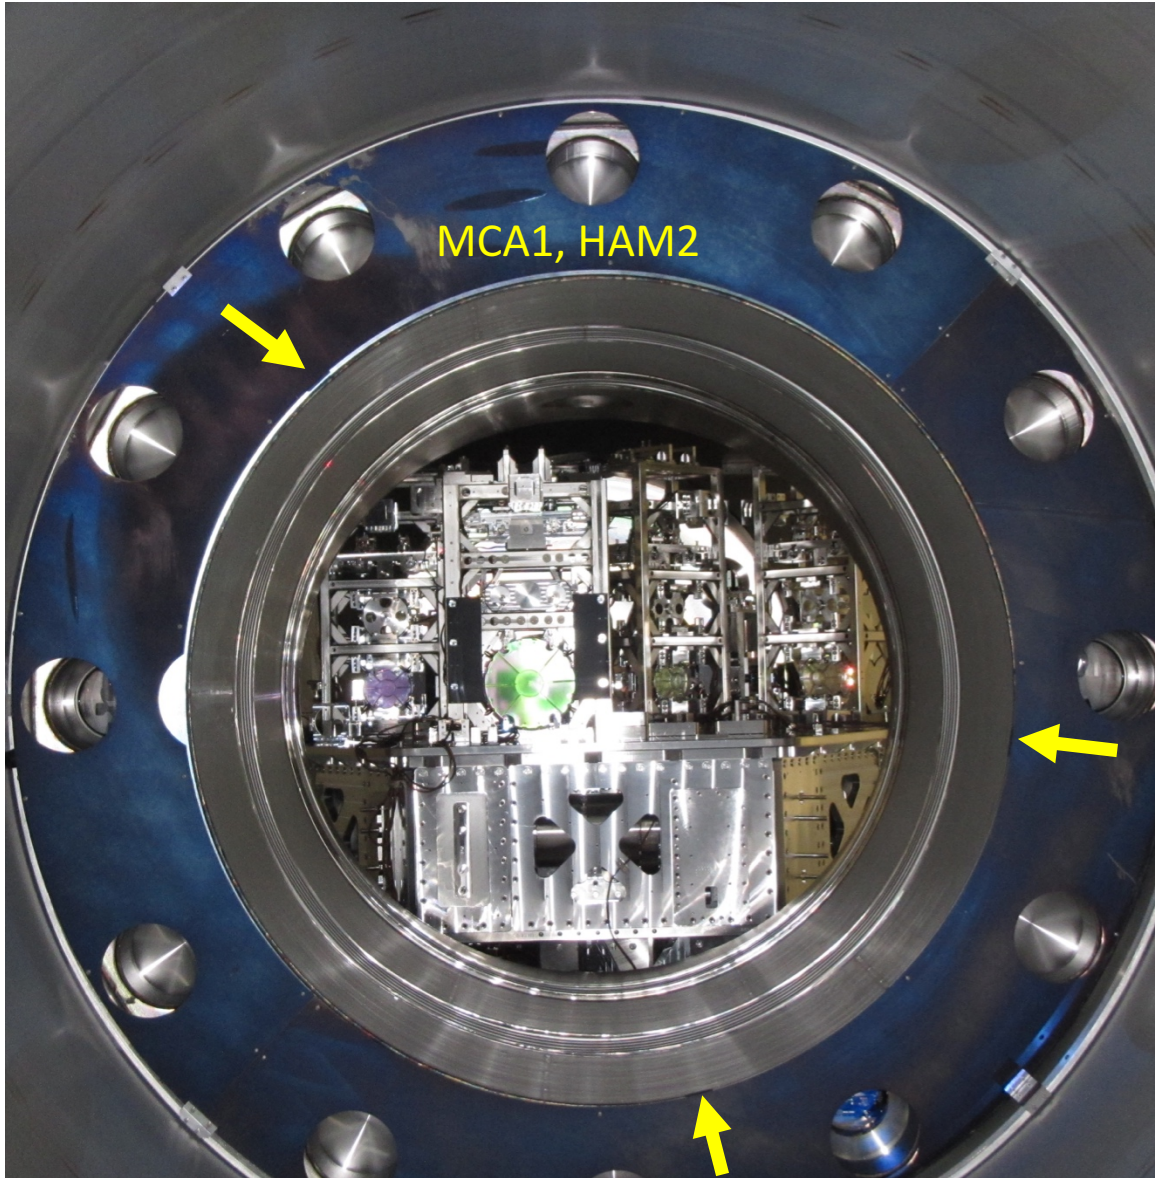
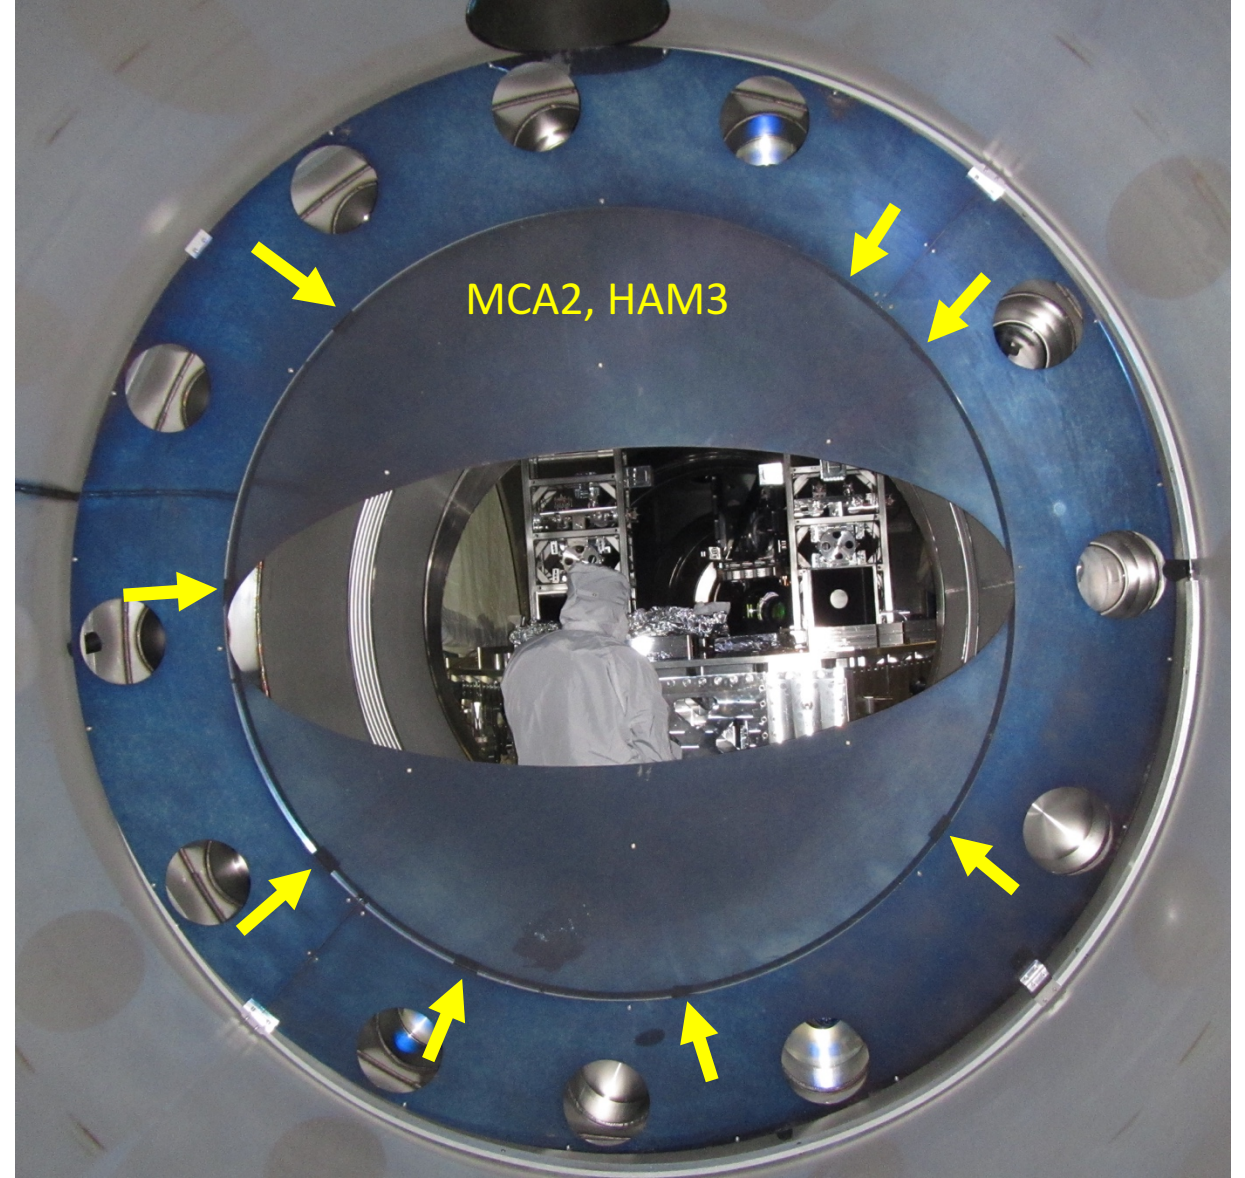
Locations of extra damping material (1/16 inch Viton sheet) added to damp baffle panels

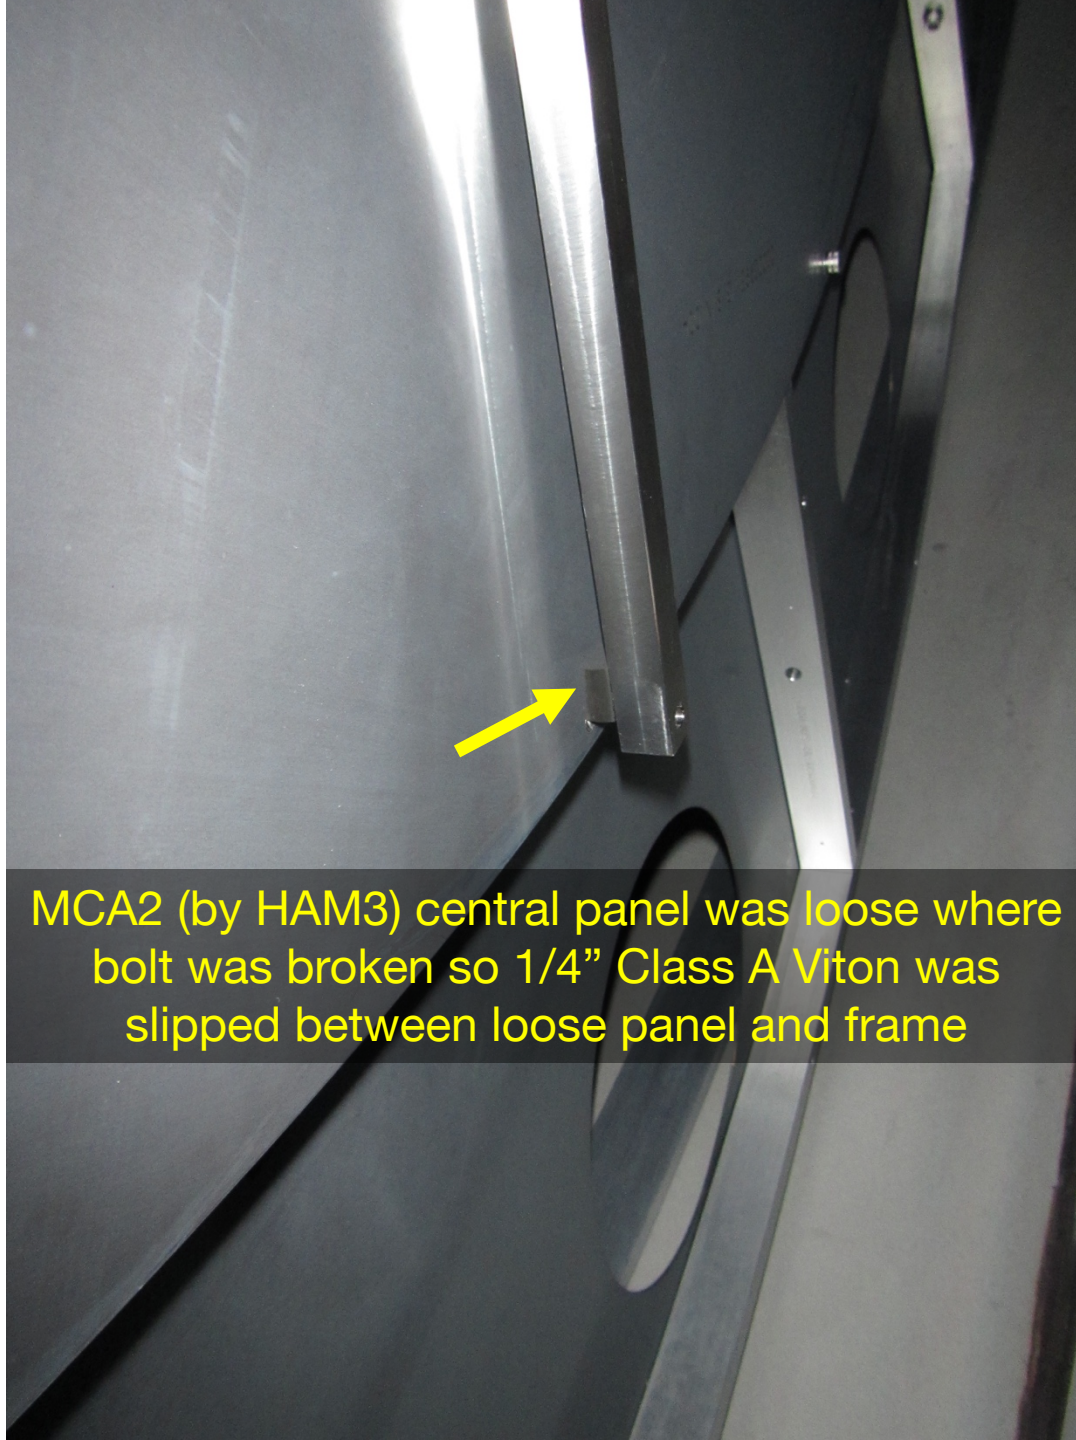
MCA2 (by HAM3) central panel was loose where bolt was broken so 1/4" Class A Viton was slipped between loose panel and frame
