**Cartoon showing that, with a tilt of only 5 degrees (3.5 in pitch and yaw), there will be regions of the baffle that are normal to light scattered from certain beam spots.**

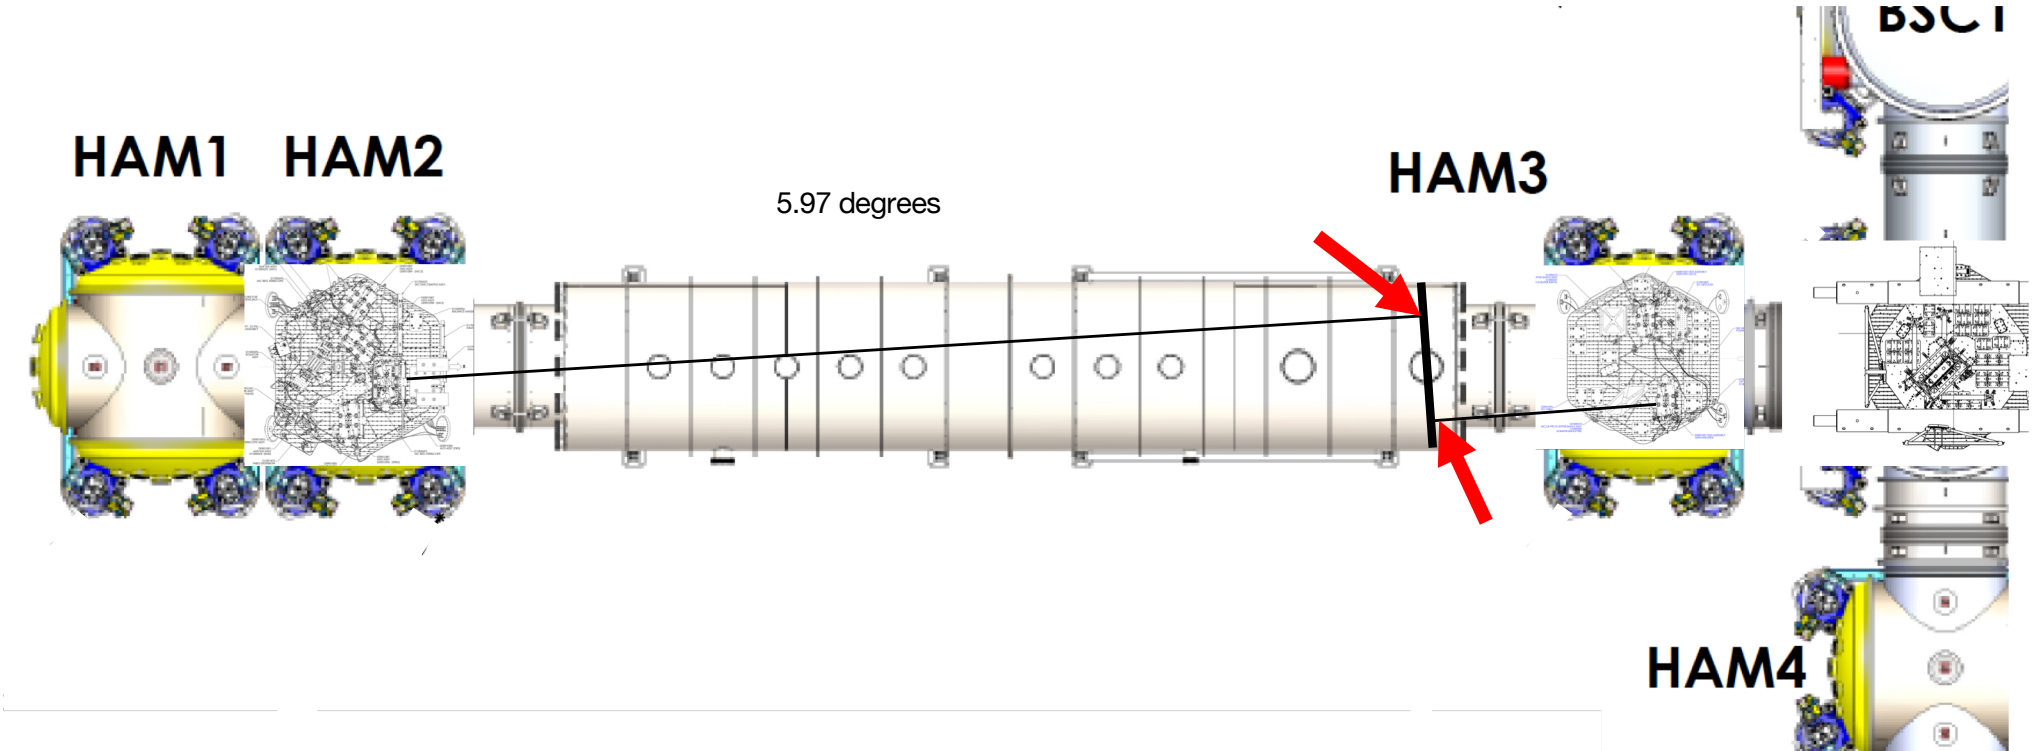
See next pages for photographs from these beam spots of the reflections from the baffles. We need to check that there are no such normal surfaces in both pitch and yaw for a new proposed angle of the baffle.

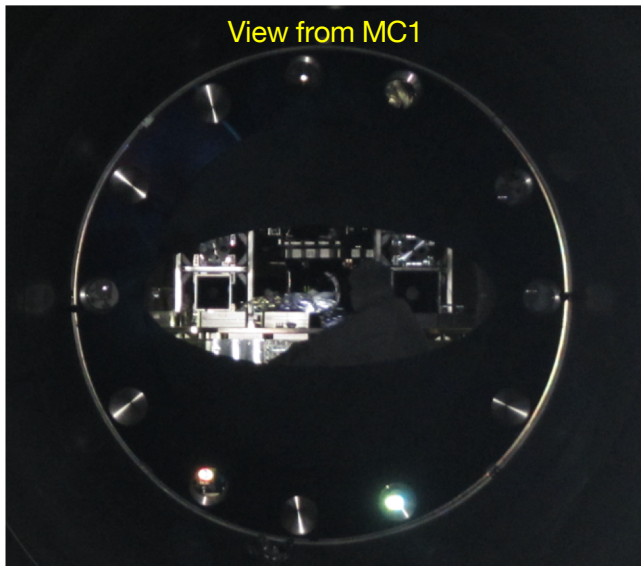
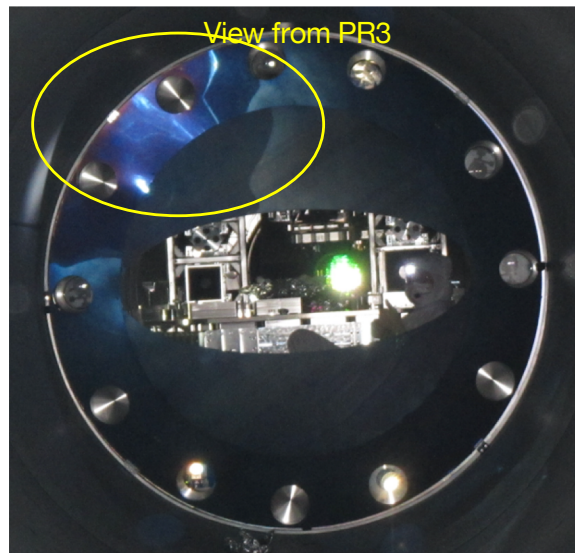
# MC baffle by HAM3, HAM2 side

Baffle angled toward PRM

Missing view from PRM

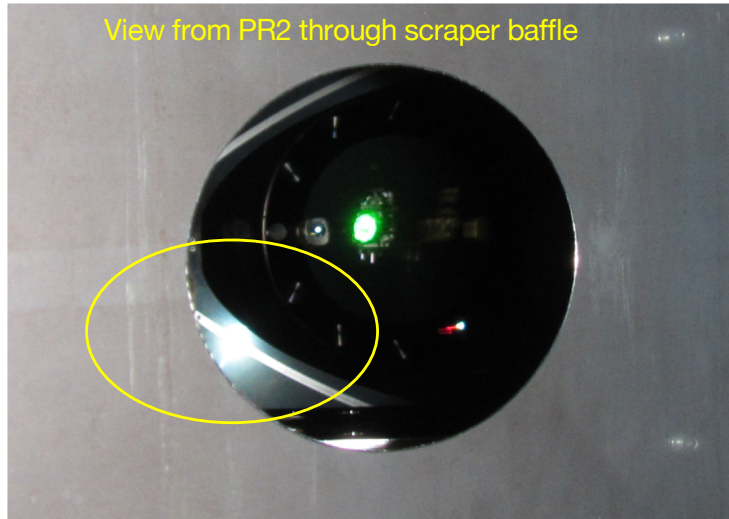
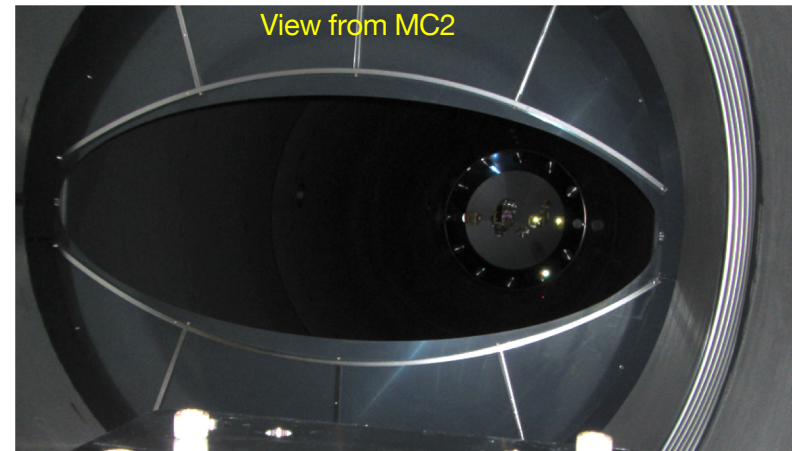
# MC baffle by HAM3, HAM3 side

Im not sure that this glint can be seen from the PR2 beamspot because the camera is somewhat in front of the optic. It would be good to check this.

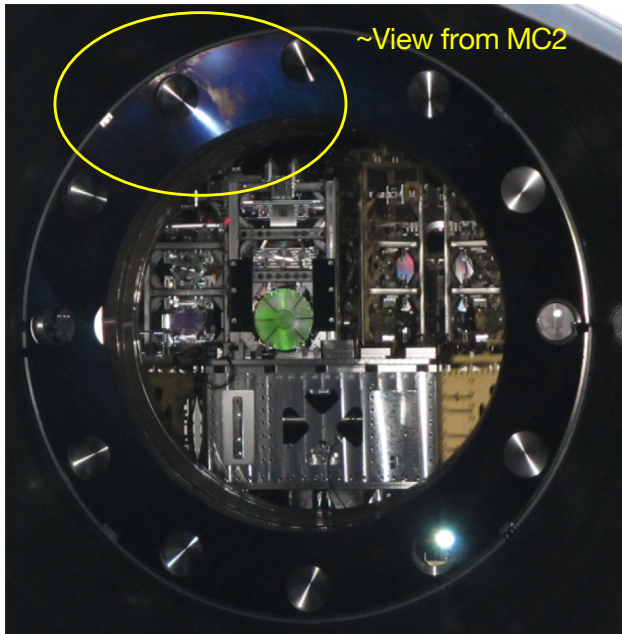
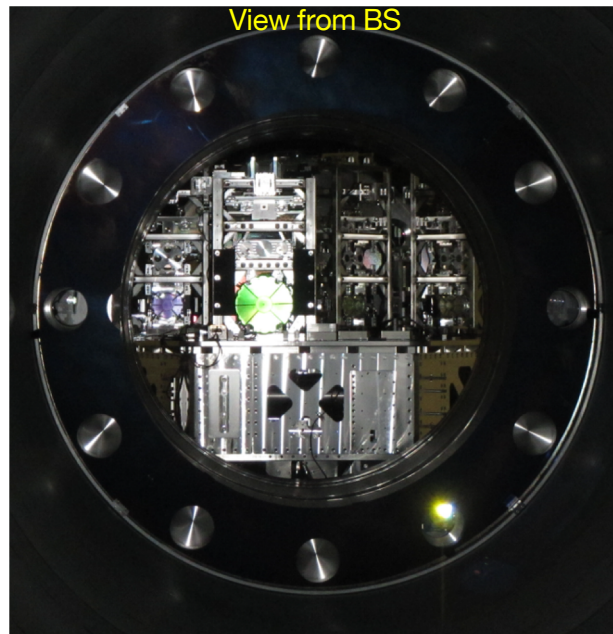
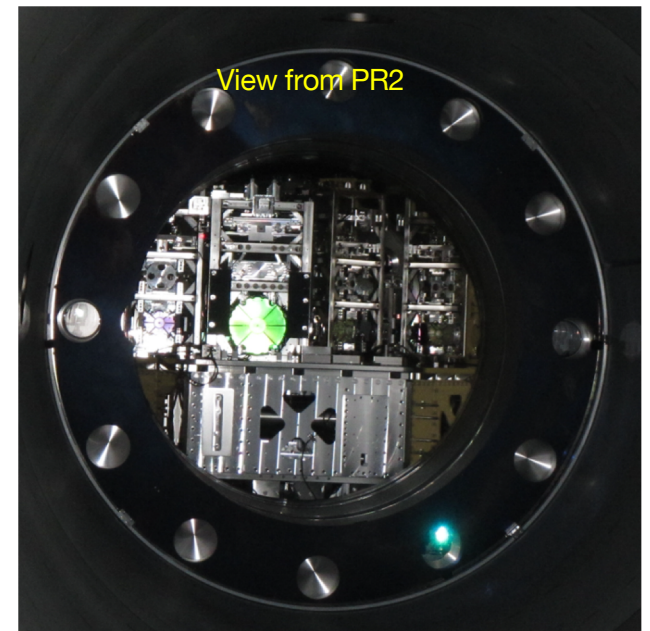
# MC baffle by HAM2, HAM3 side

Baffle angled toward MC2
