# Laser vibrometer signal from baffle after impulse to beam tube shows decaying 4 Hz resonance

# Laser vibrometer spectra before and after damping

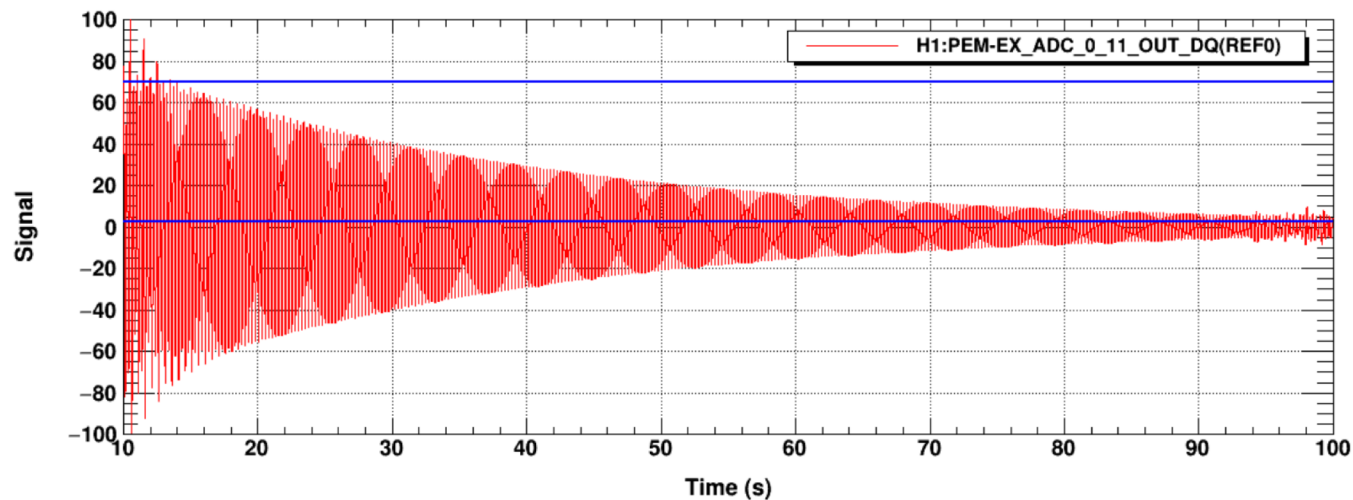
Before damping,  
Q about 400

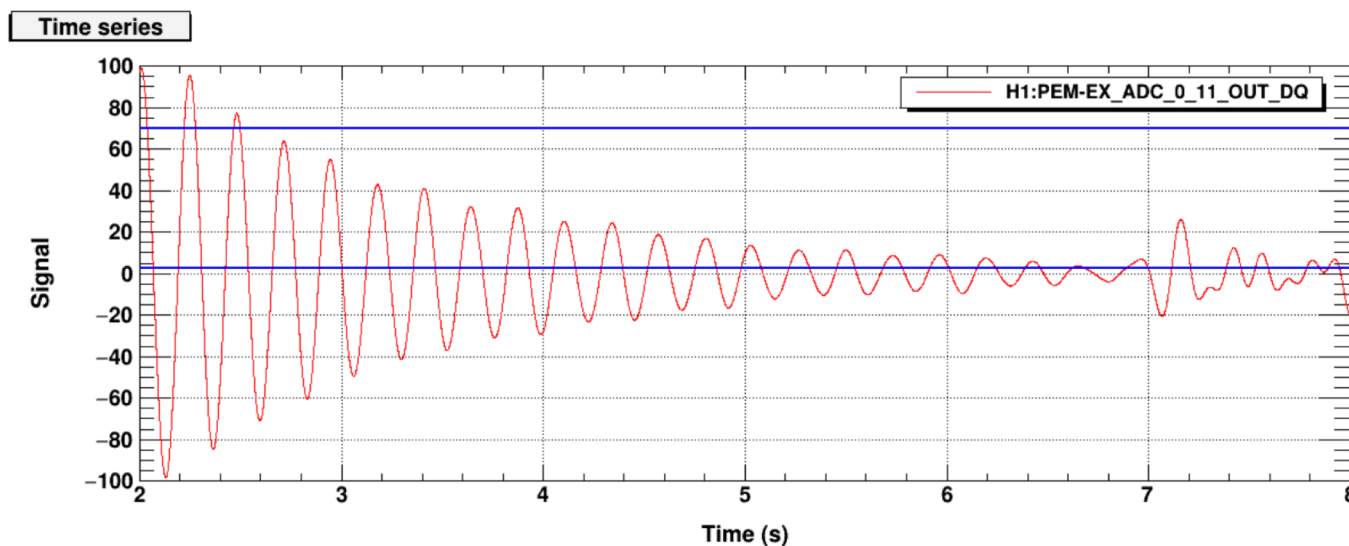
After damping,  
Q about 20

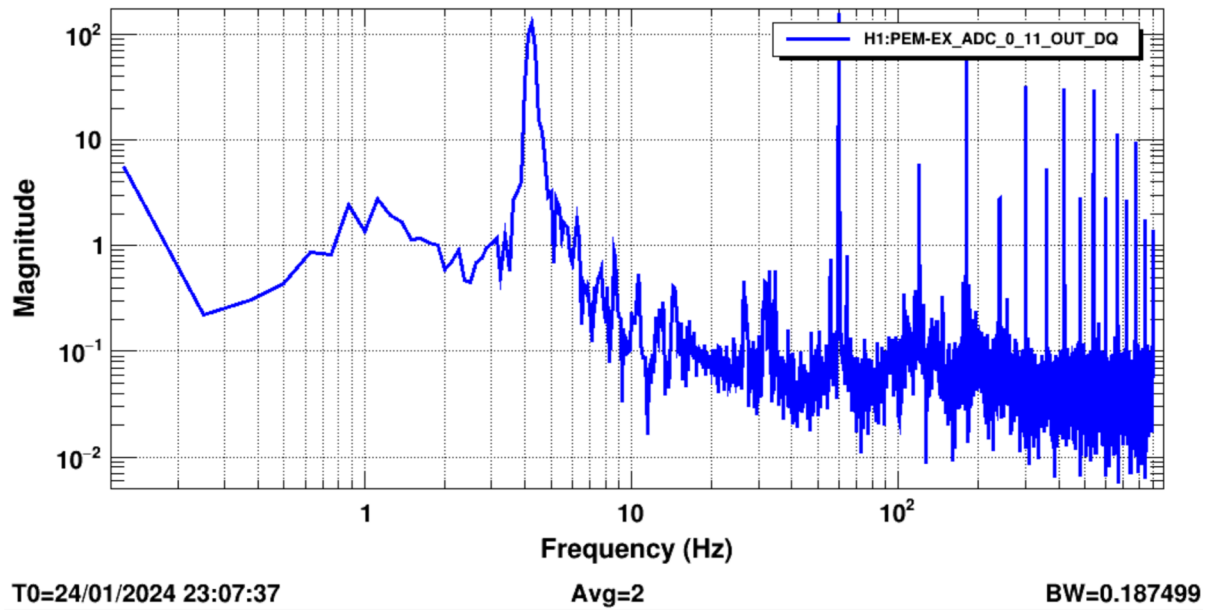
**after**

Similar peak frequencies suggest the baffle is not hitting eddy current dampers etc.
