Before/after view from PR3 towards MC baffle by HAM3 using IR Camera and 940 nm illuminator

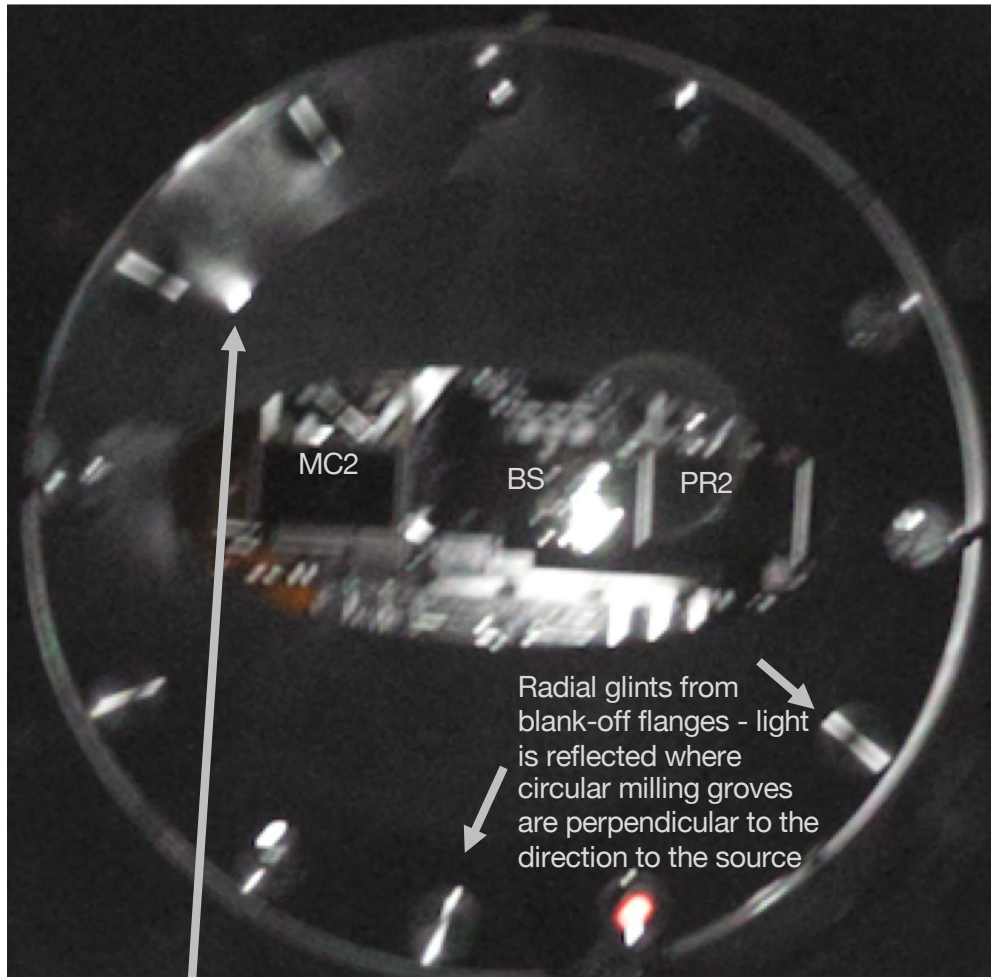
Before

One of the bright glints that we were trying to get rid of by increasing angle of baffle.

Lighting experiments showed that this light patch was caused by the illuminator light reflecting from the beam tube onto the baffle – this may not be a problem because the distribution of light scattered from the optics is probably narrower than the illuminator beam.

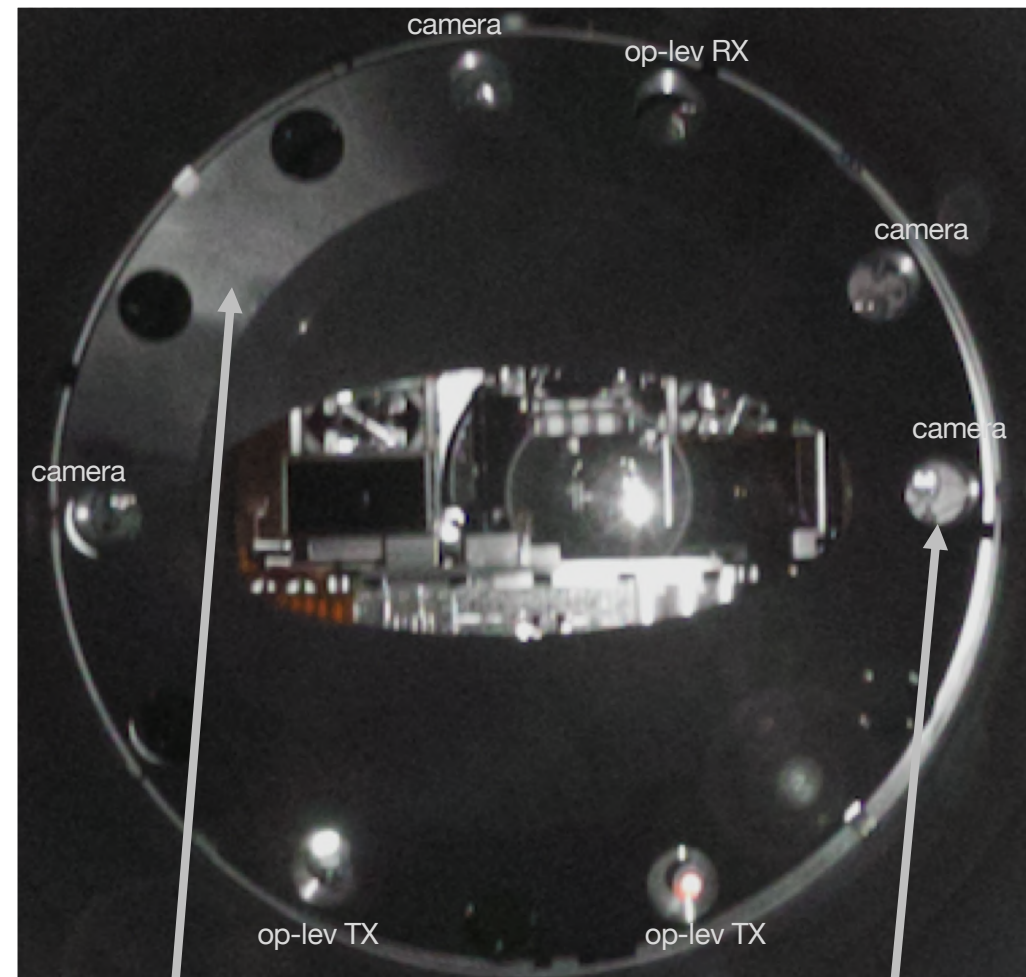
After increasing angle to 10 degrees and installing nozzle baffles on blank-off flanges

Reflection from PRM camera and box. It is even more strongly retro-reflecting of the light from PRM – see PRM view below – and should probably be treated.

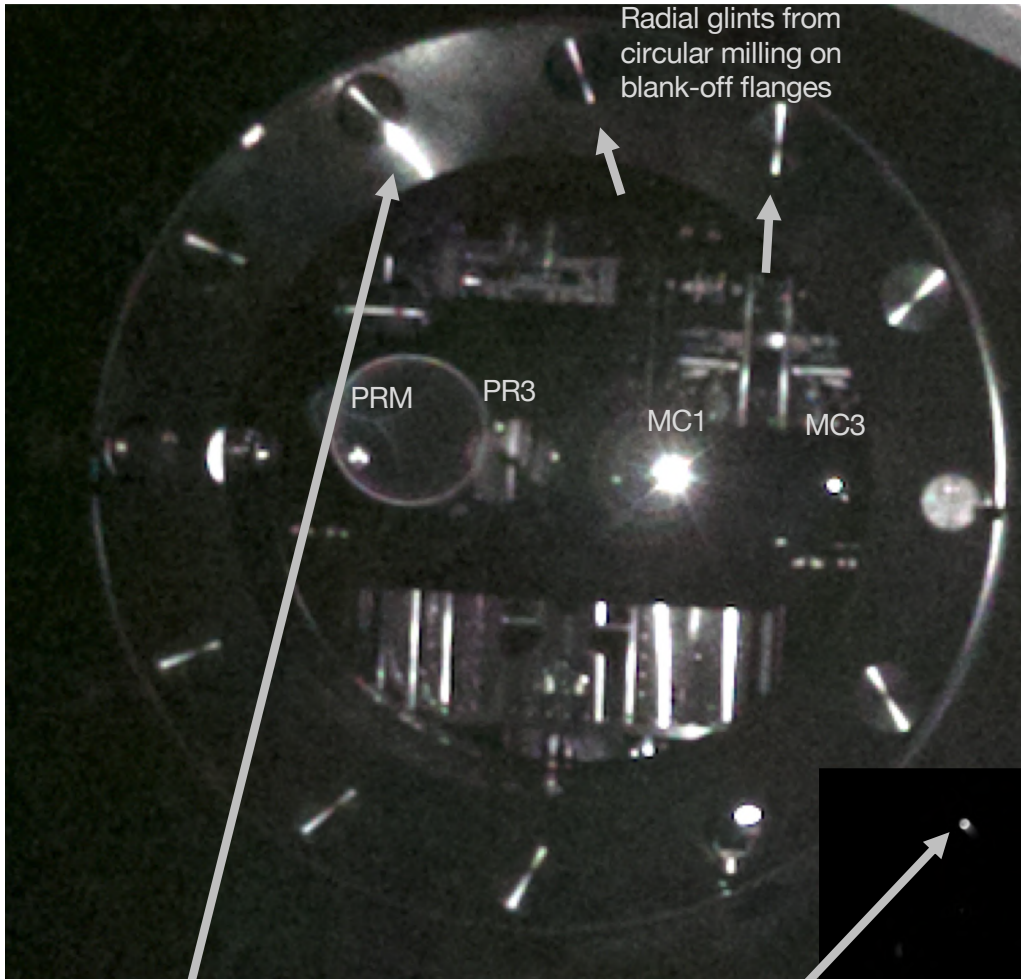
Before

One of the bright glints that we were trying to get rid of by increasing angle of baffle.

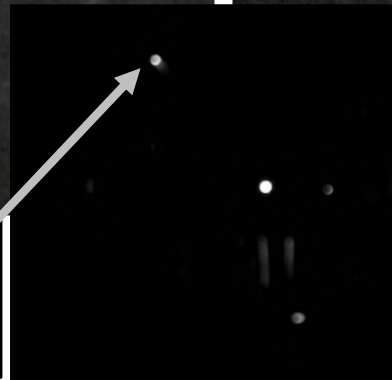
Same view at lower exposure showing how bright glint was before baffle angling

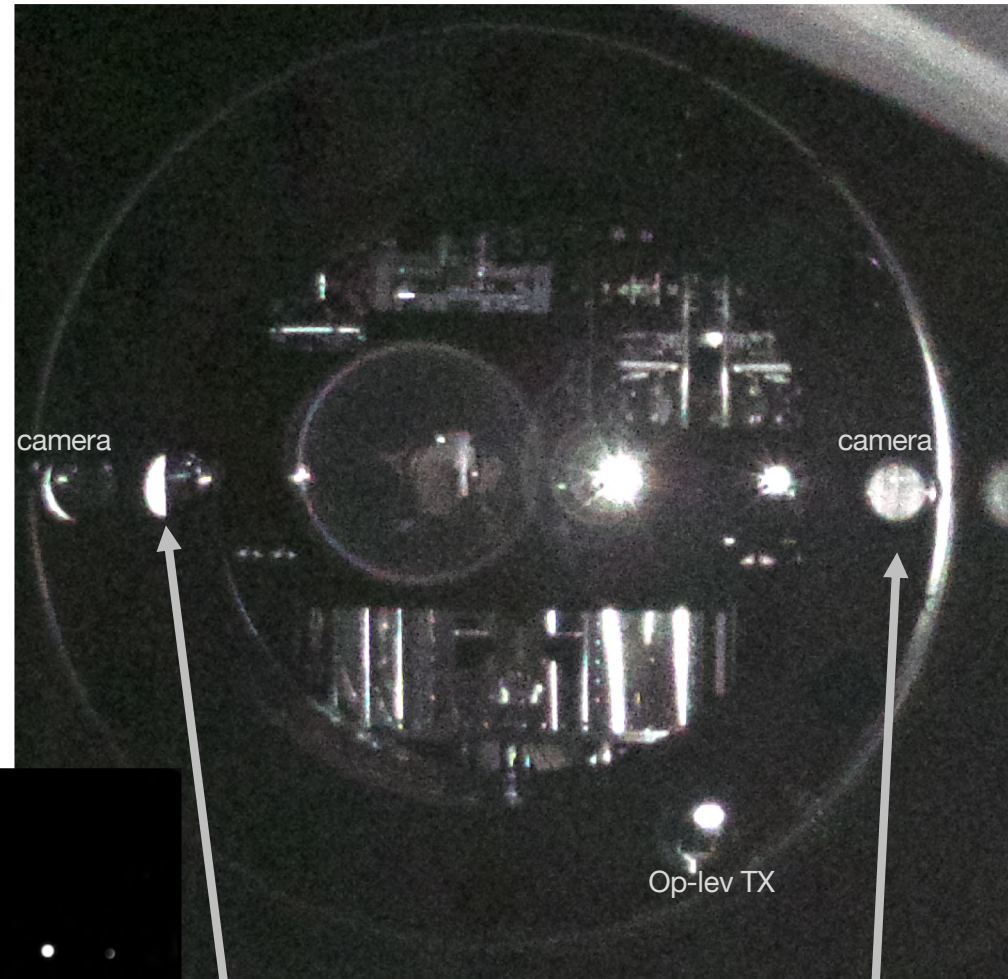
After increasing angle to 10 deg. and installing nozzle baffles on blank-off flanges

Baffle cutout for PRM allows retro-reflection of light scattered from MC2

Strong reflection from MC2 camera box should probably be treated
