2014-08-14 LHO LVEA Slab Characterization

created by analyze_LHOLVEA_SlabCharacterization_20140814 on 14-Aug-2014, J. Kissel, T. MacDonald

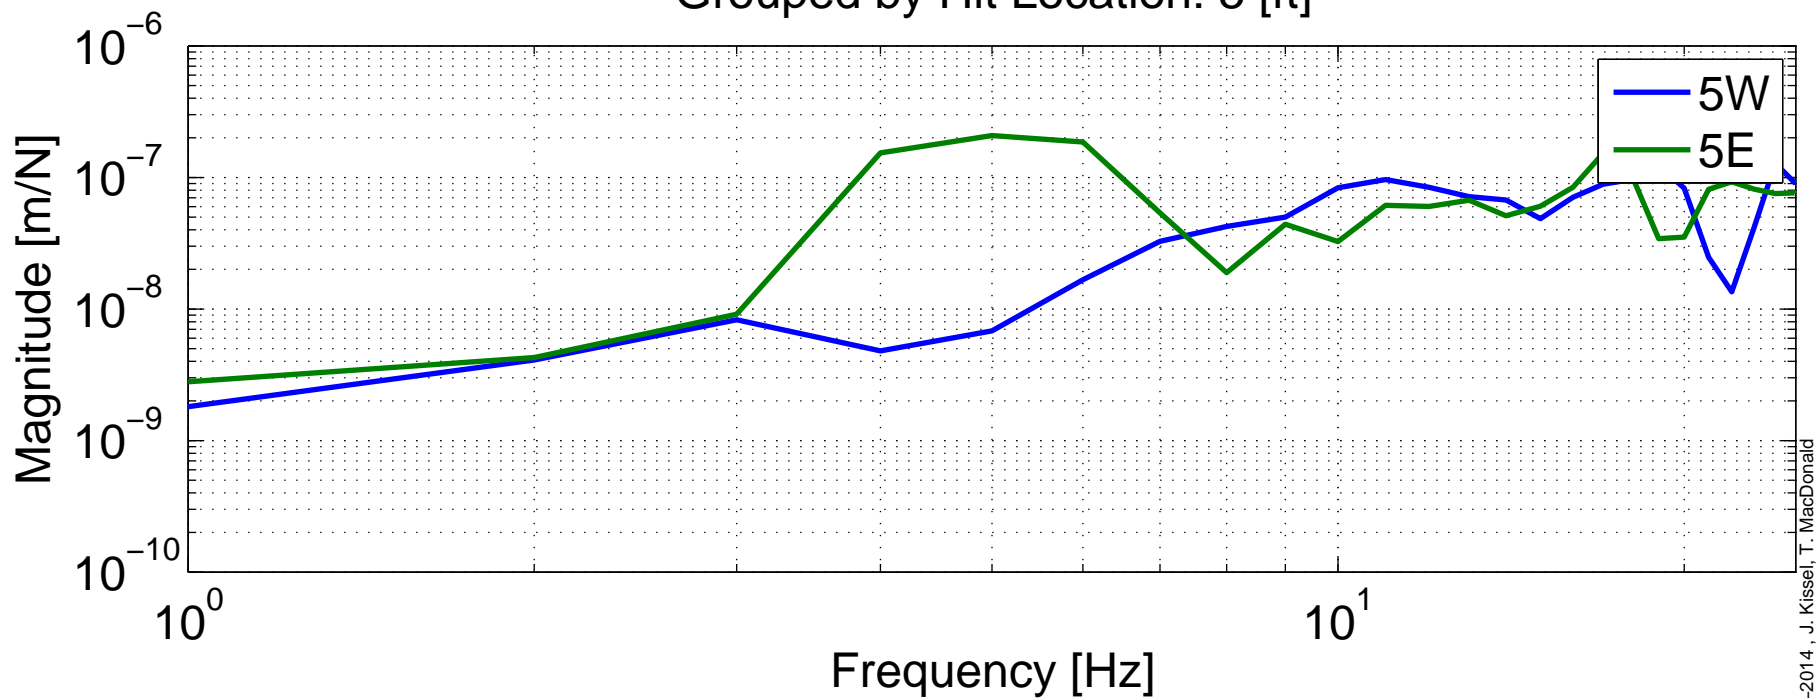
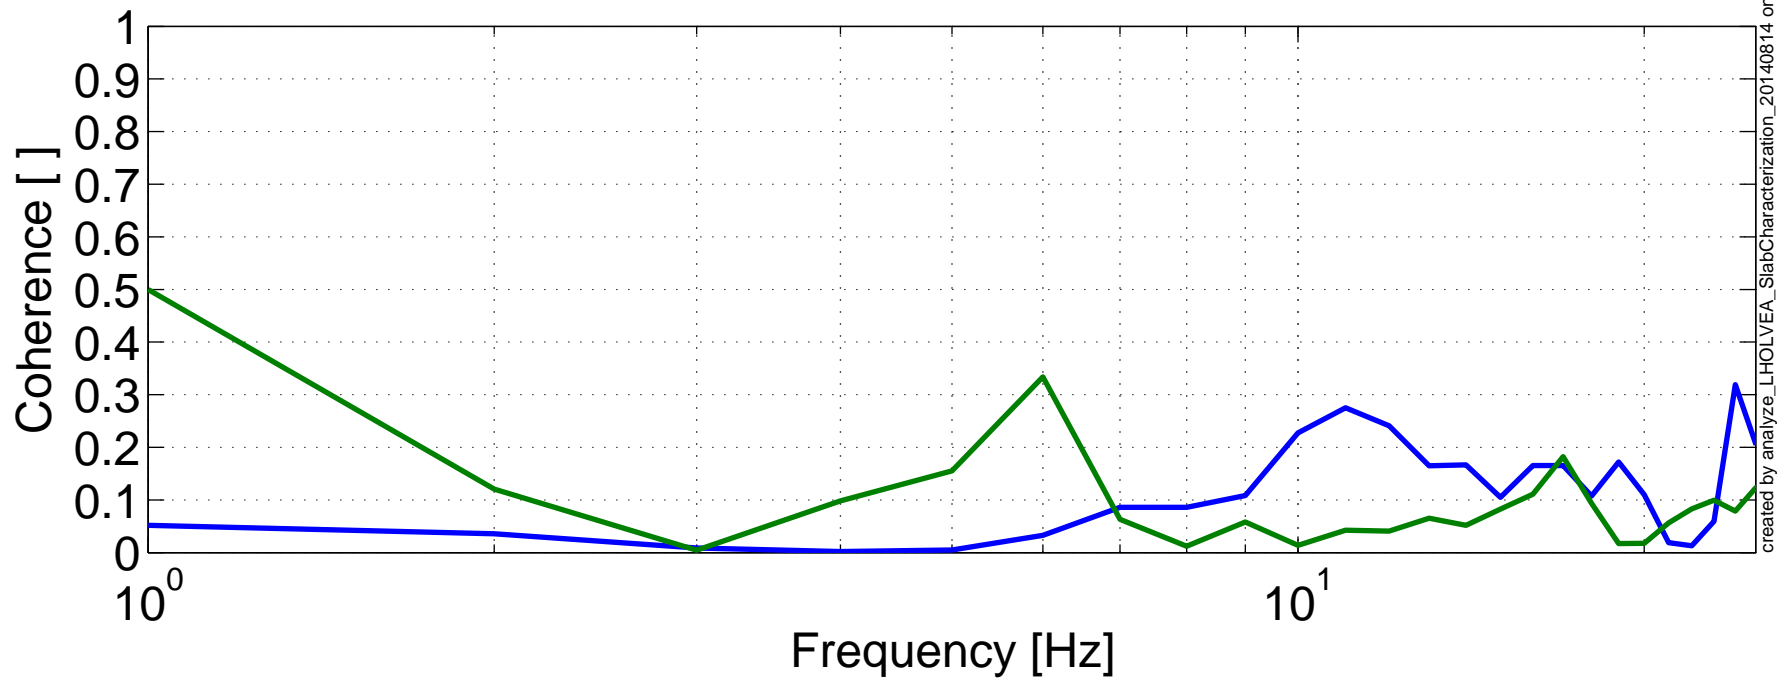
Grouped by Hit Location: 5 [ft]

2014-08-14 LHO LVEA Slab Characterization

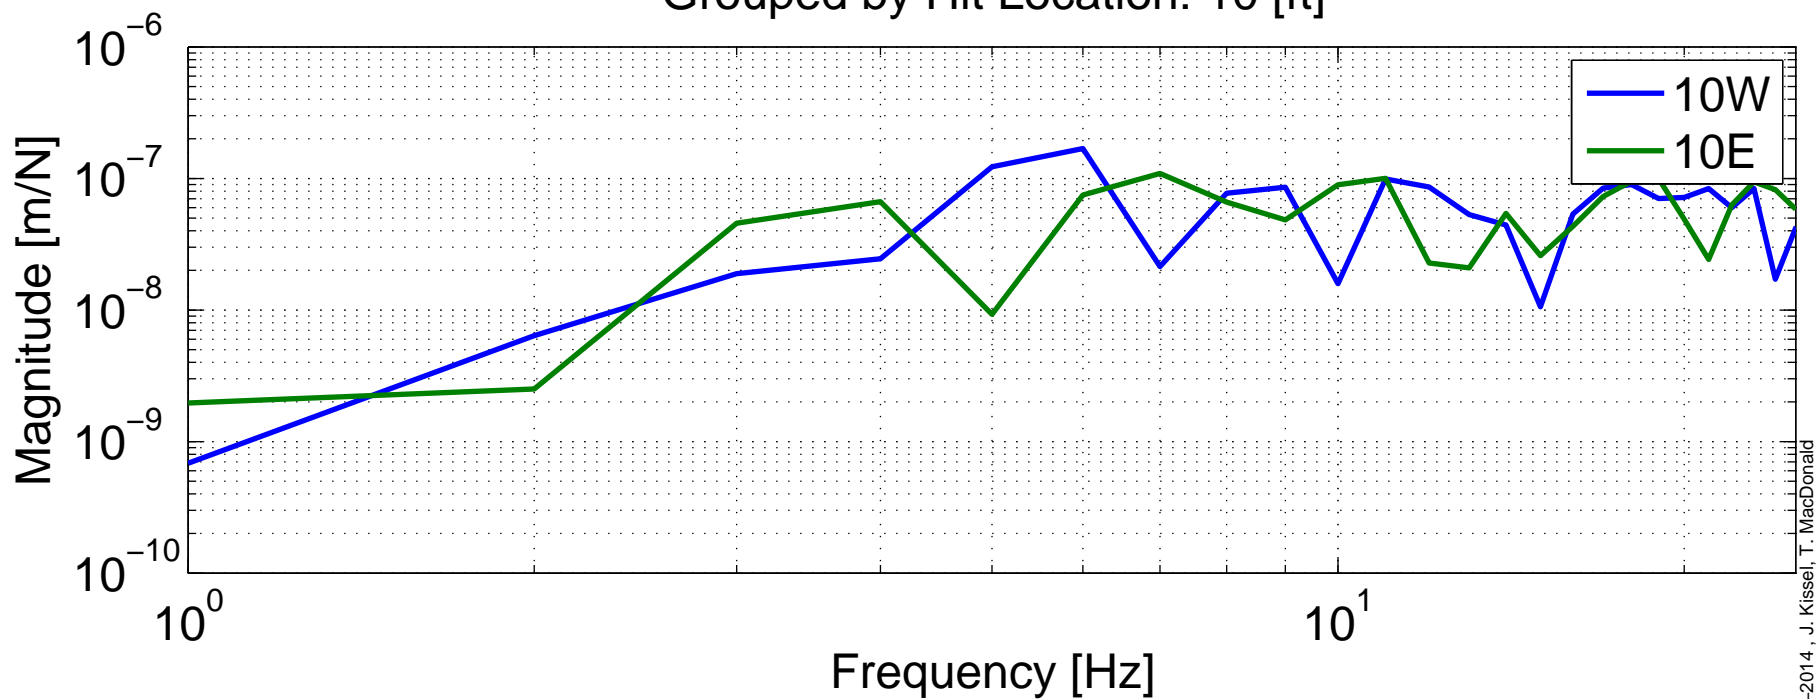
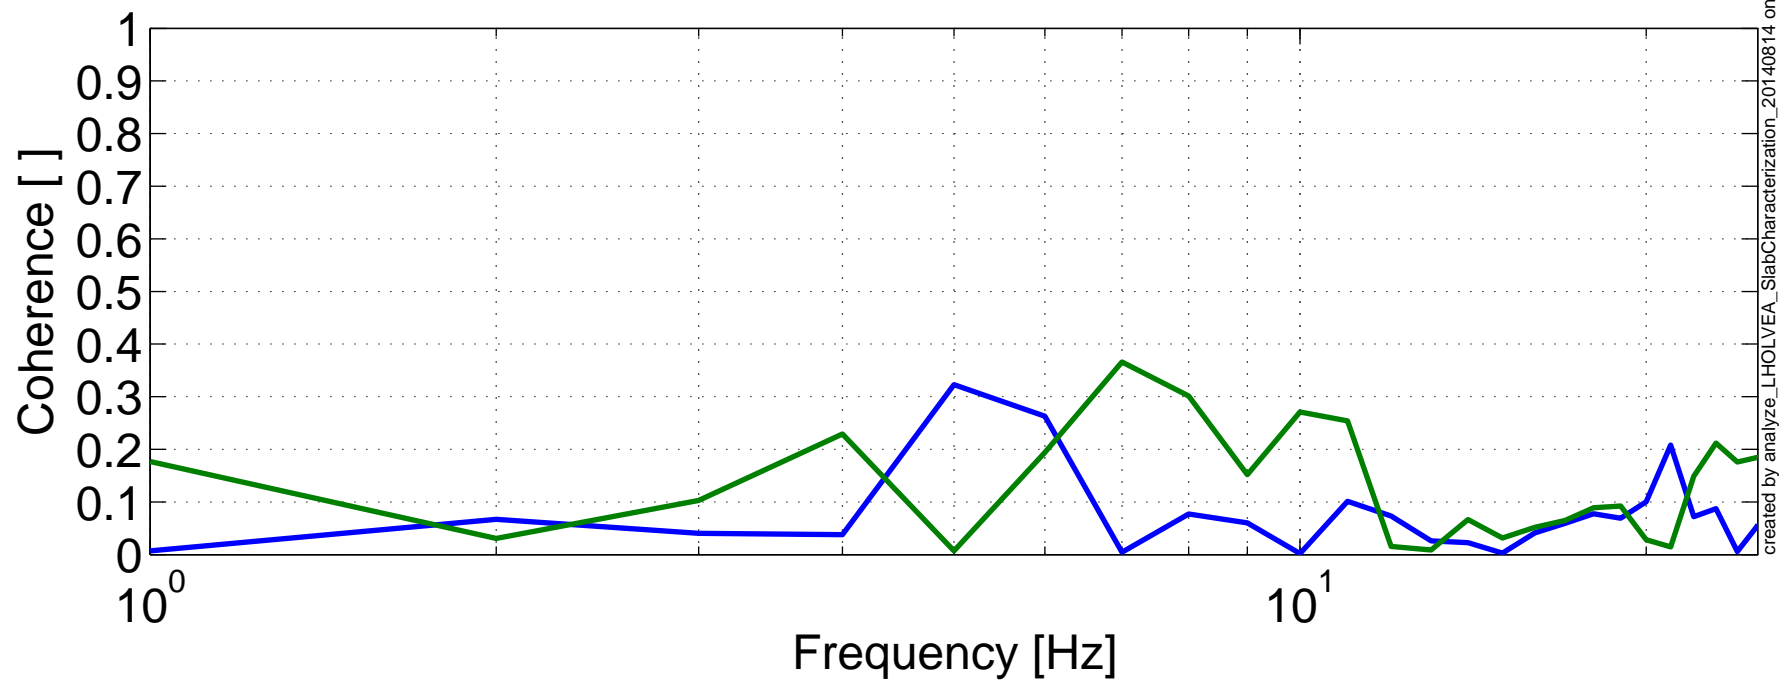
Grouped by Hit Location: 10 [ft]

2014-08-14 LHO LVEA Slab Characterization

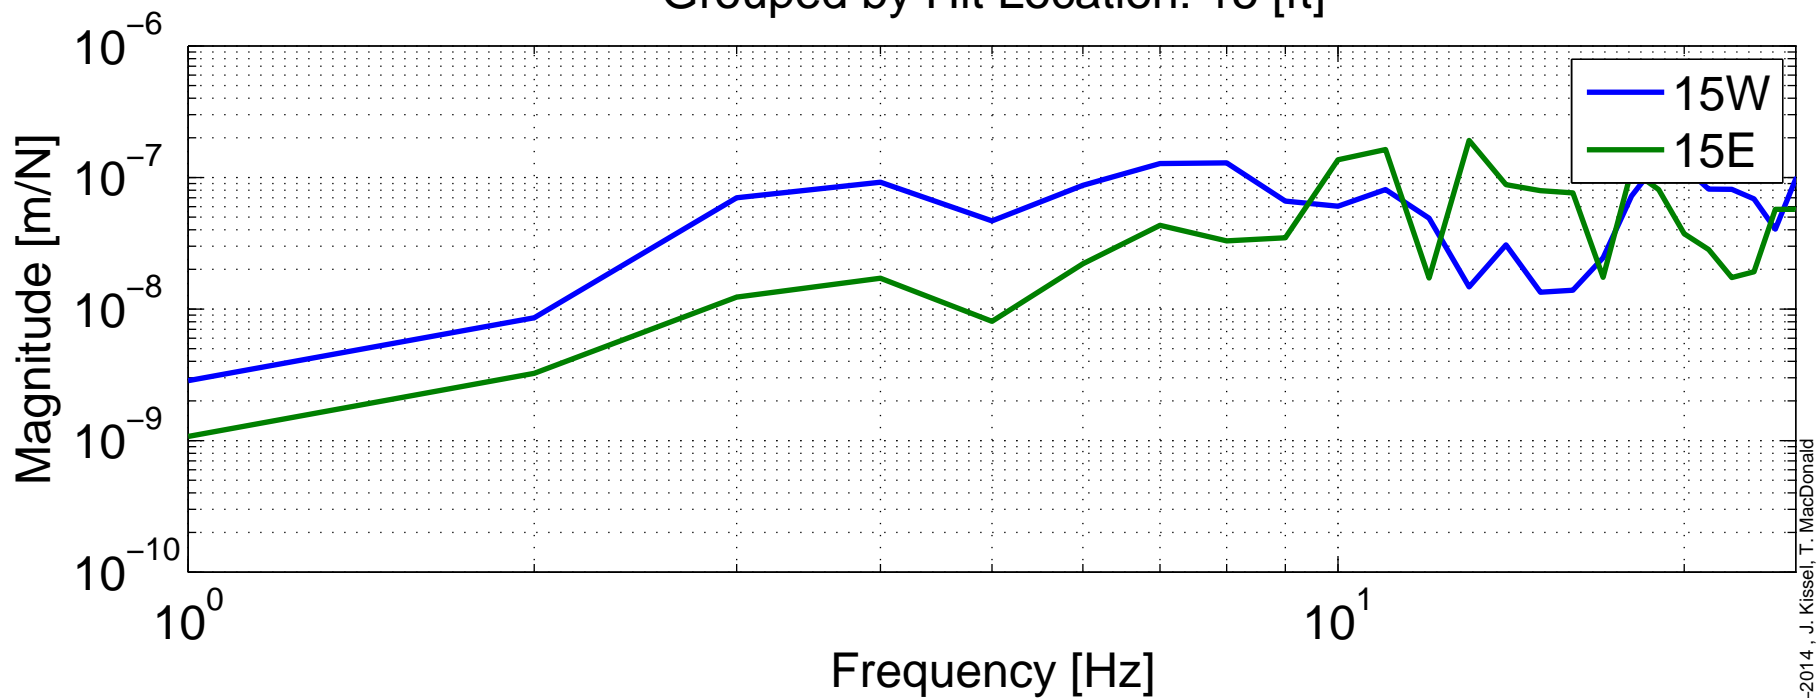
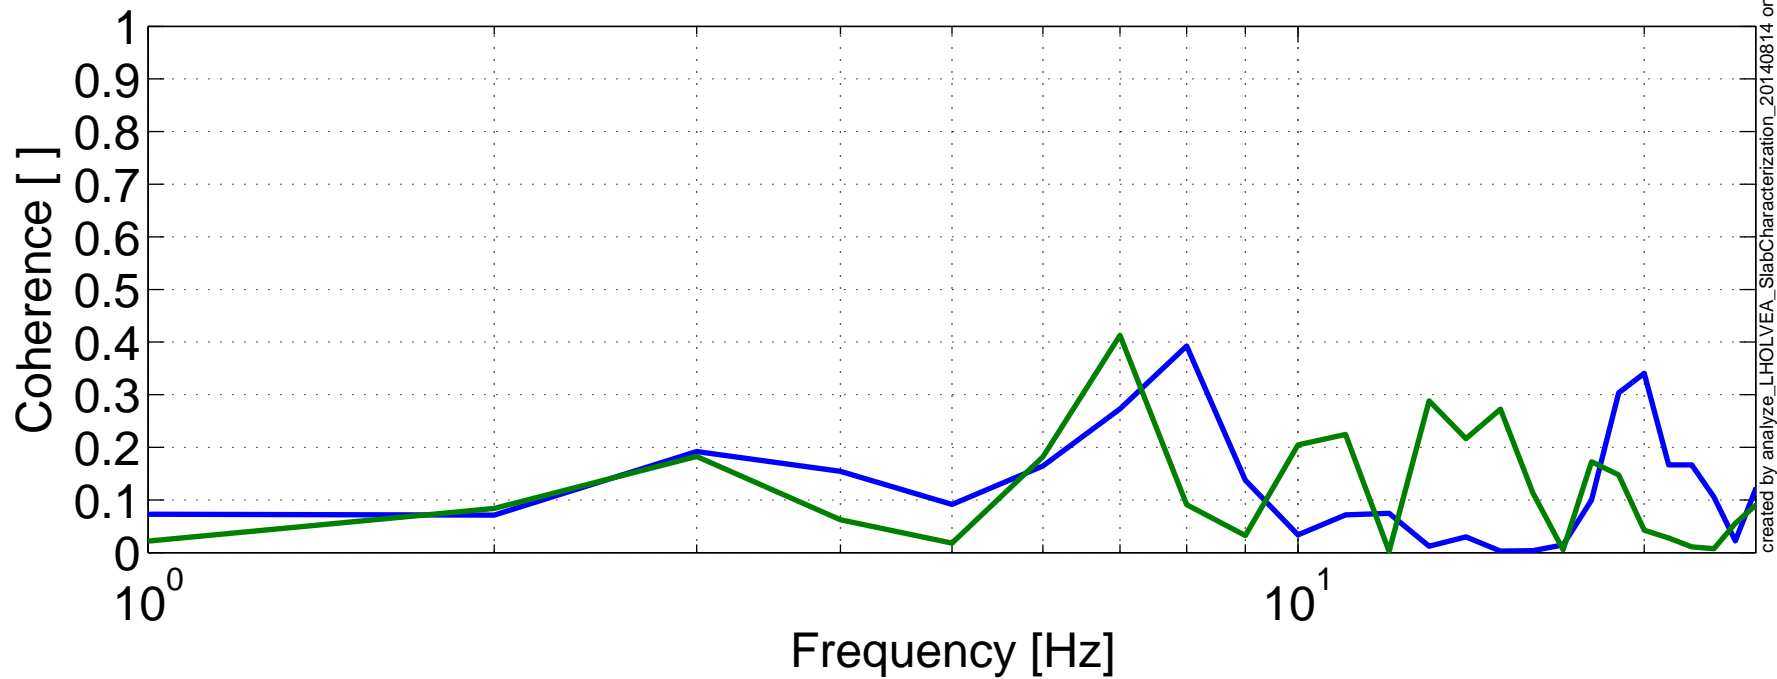
Grouped by Hit Location: 15 [ft]

2014-08-14 LHO LVEA Slab Characterization

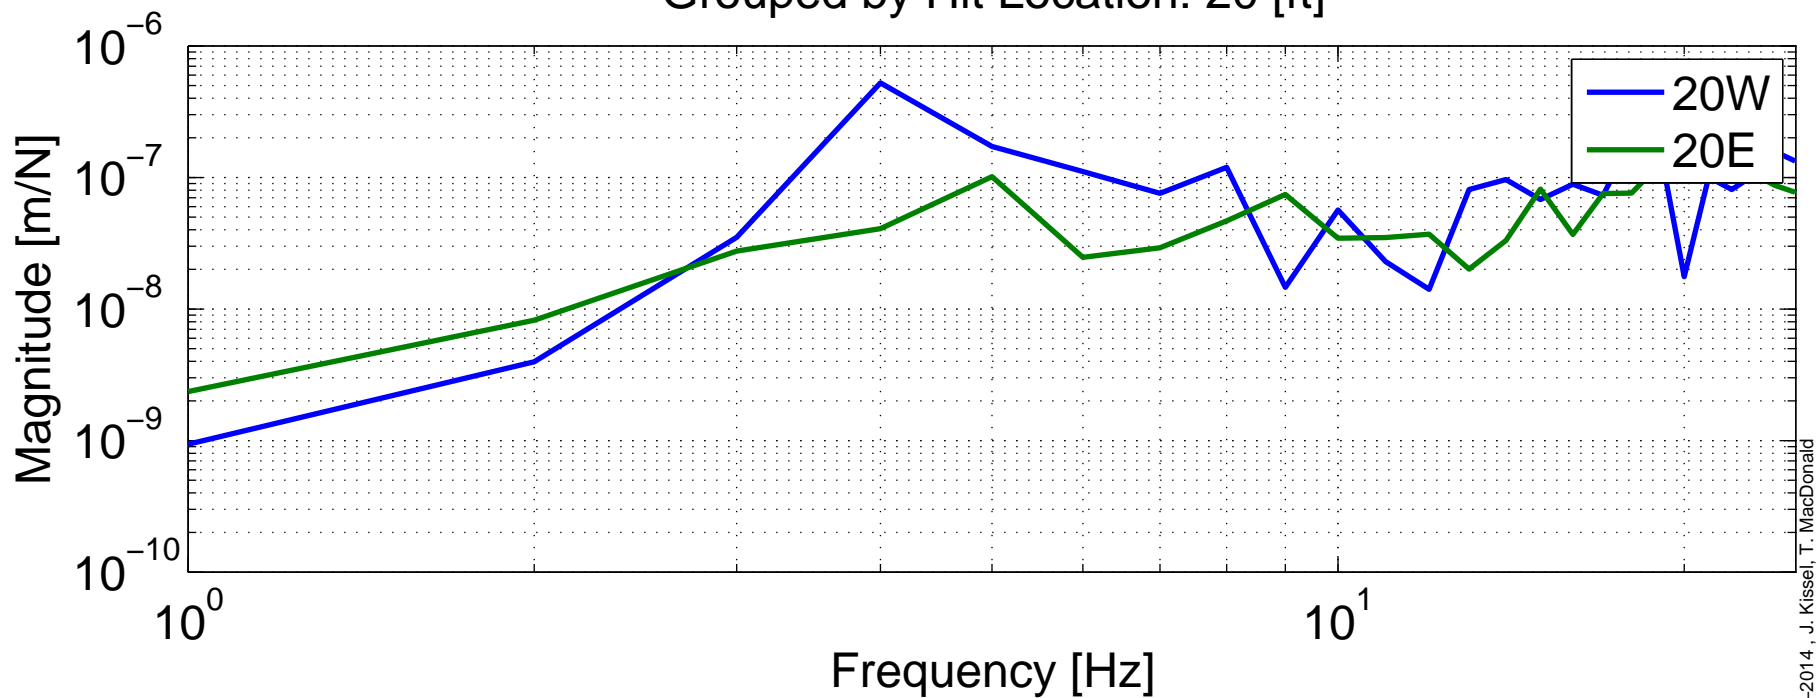
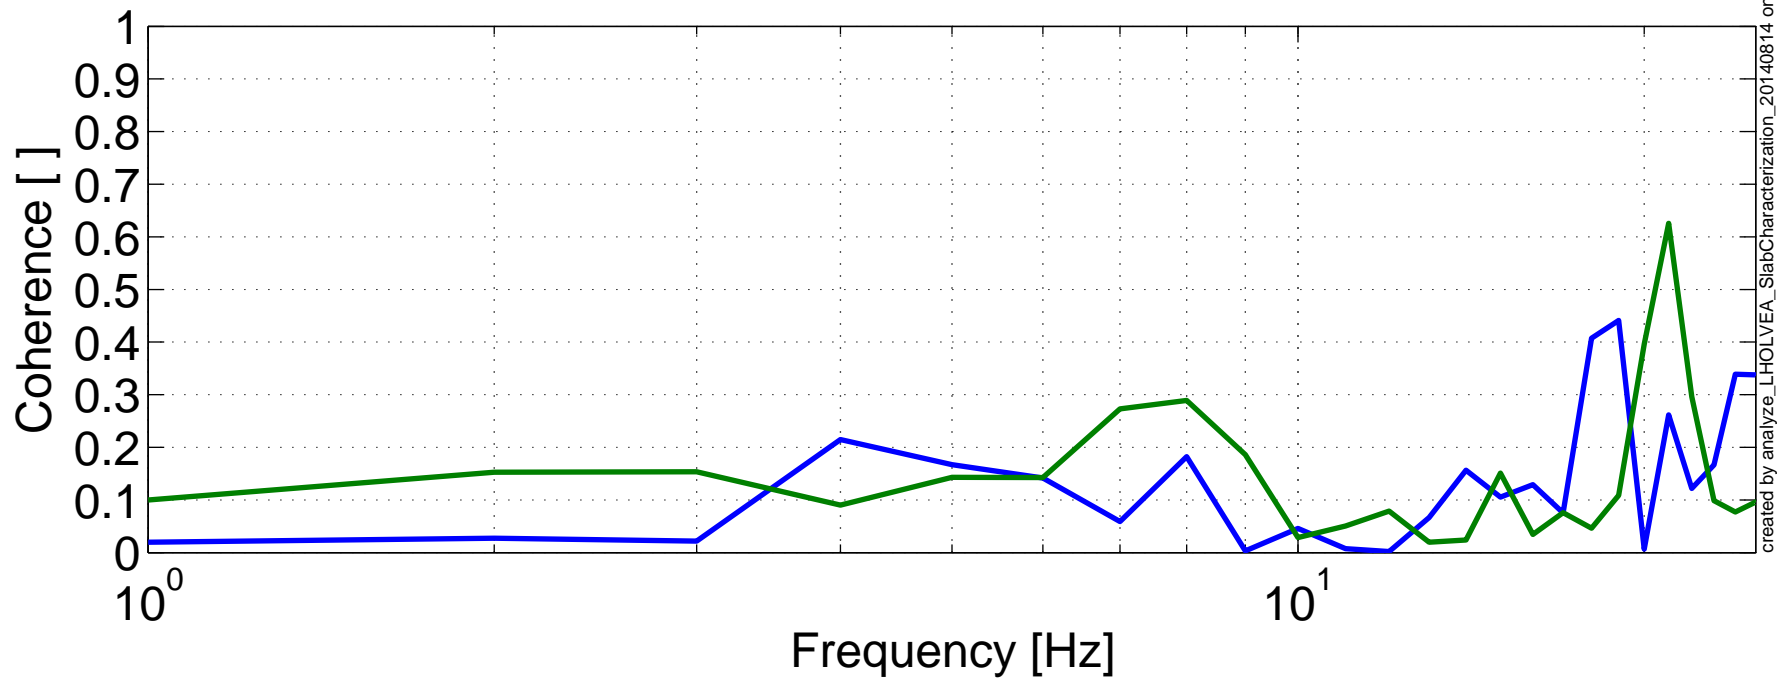
Grouped by Hit Location: 20 [ft]

2014-08-14 LHO LVEA Slab Characterization
