HAM-ISI Unit #4 – Investigation Of Unusual HF Resonances/Noise

SEI-LHO

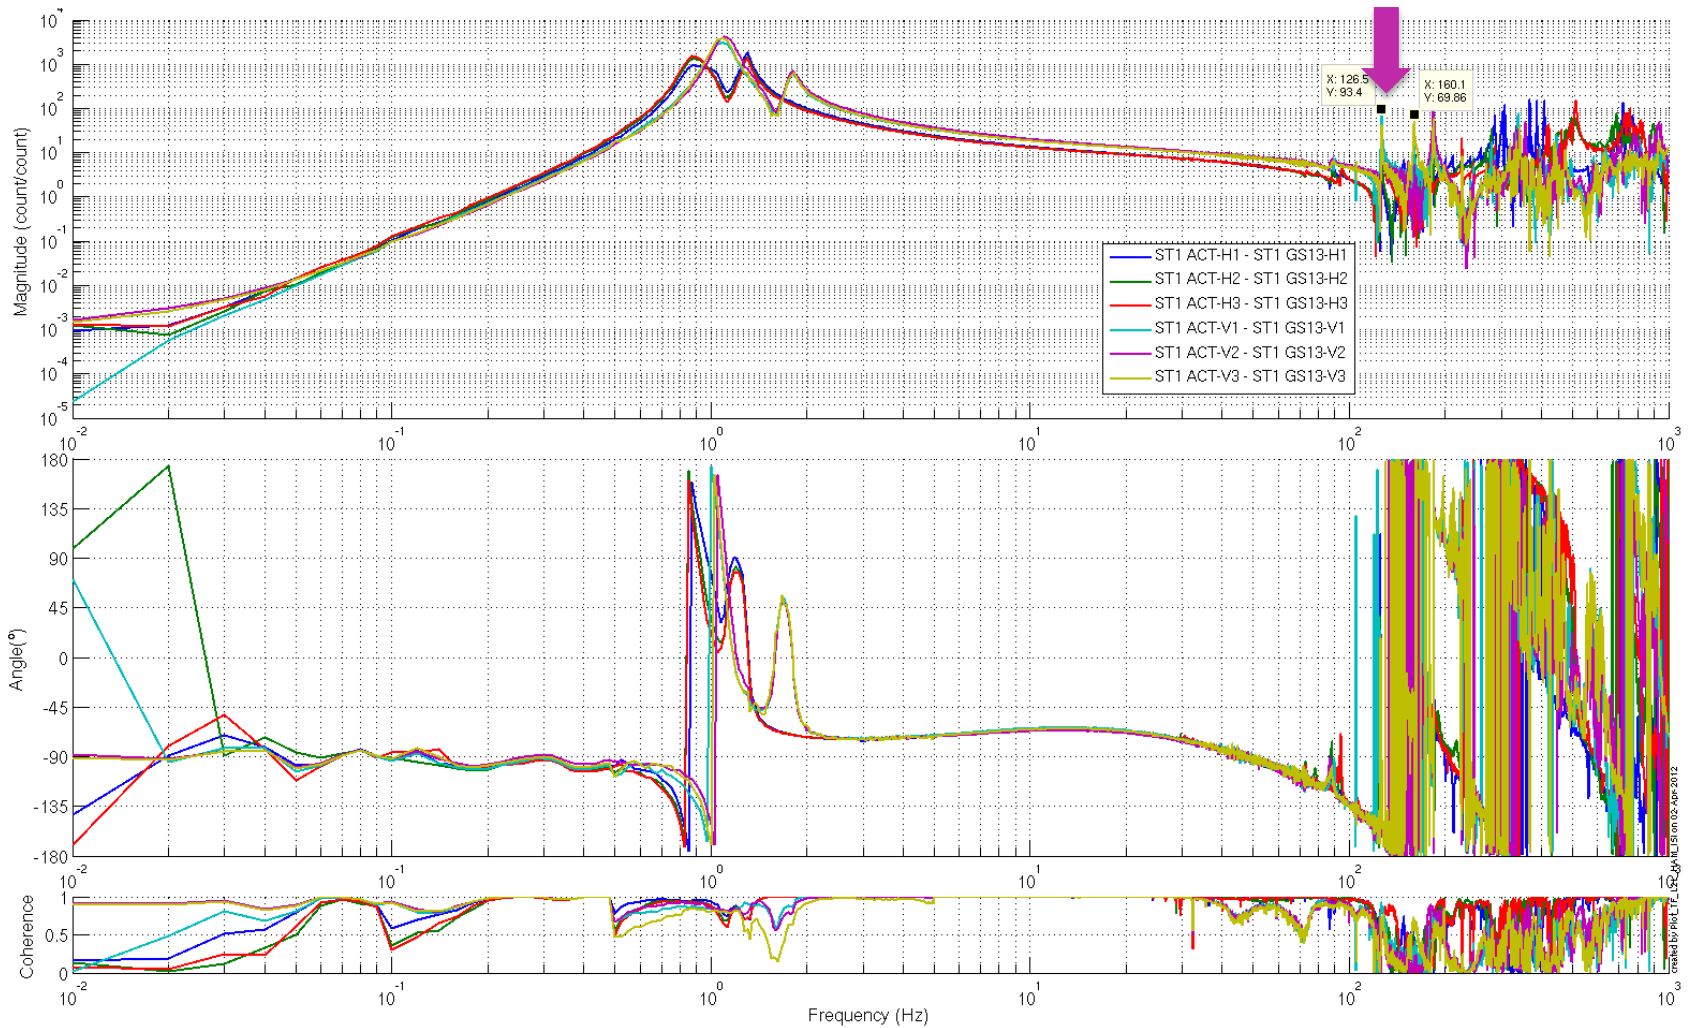
Top Mass Sitting On Small Washers – 1 Small Washer Set On Optical Table Tracks

One can hear the top mass of the optical table ringing when being hit

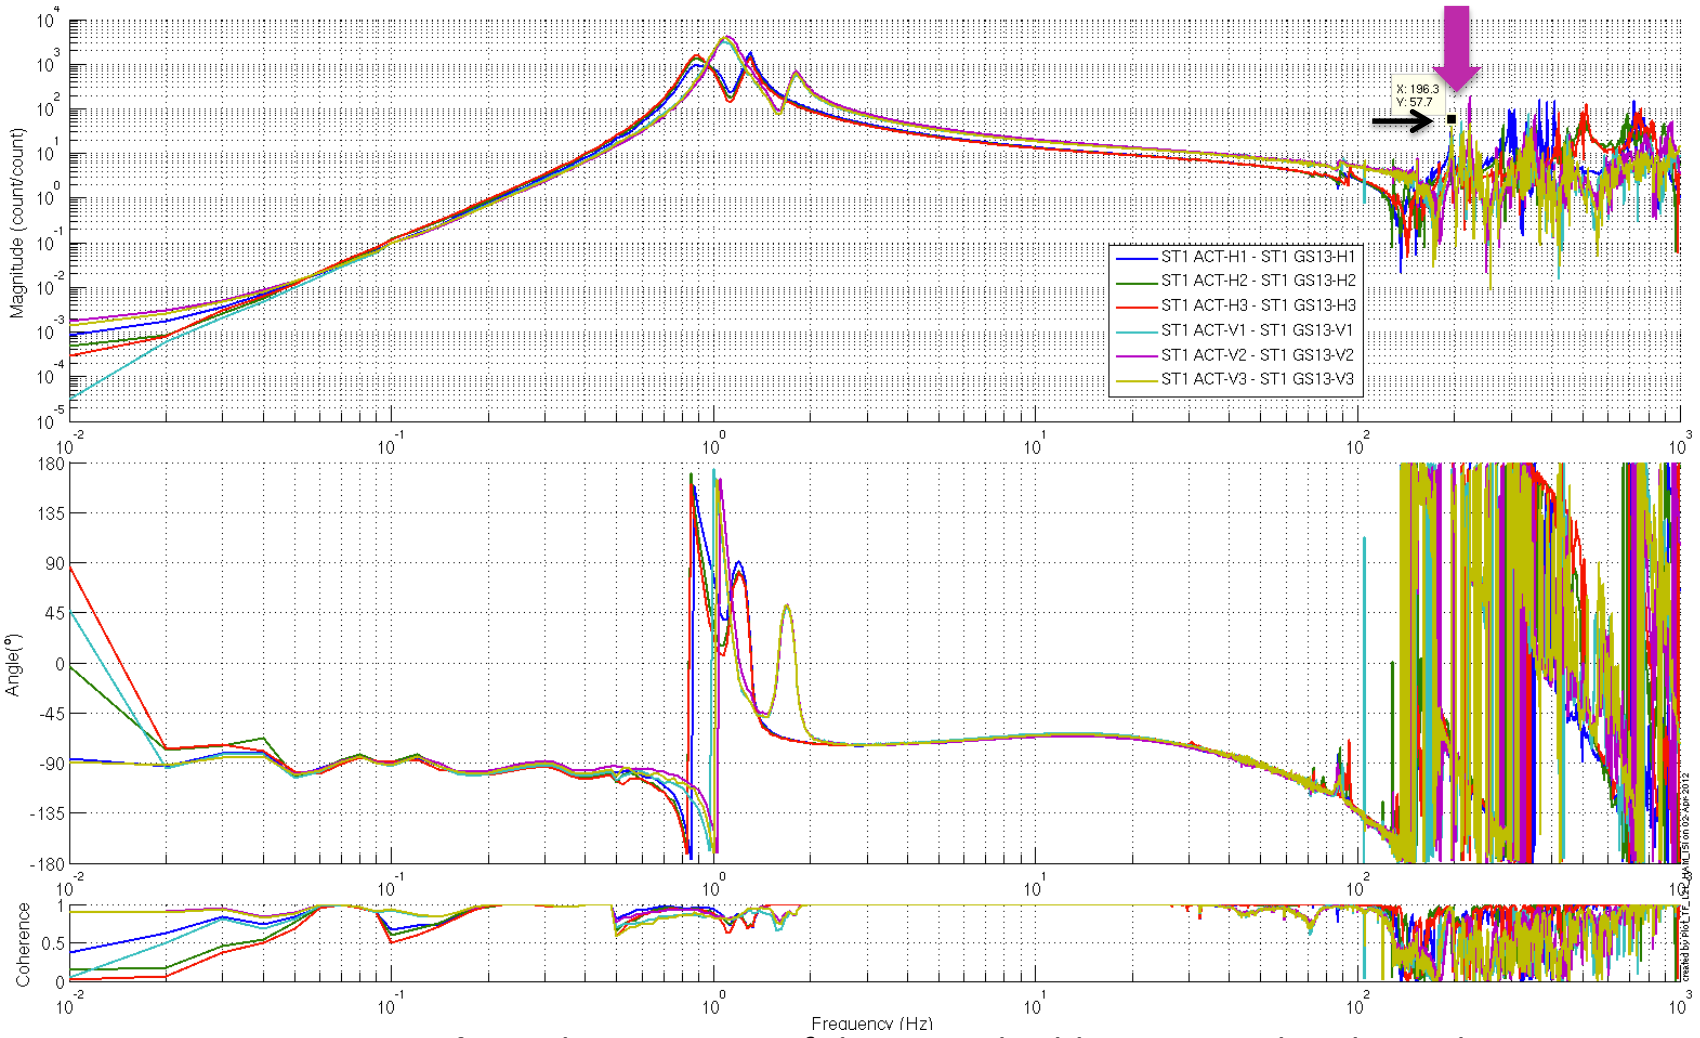
One can NOT hear the top mass of the optical table ringing when being hit

Small Washers Removed And Replaced With Thicker Ones Which Were Set Away From The Optical Table Tracks

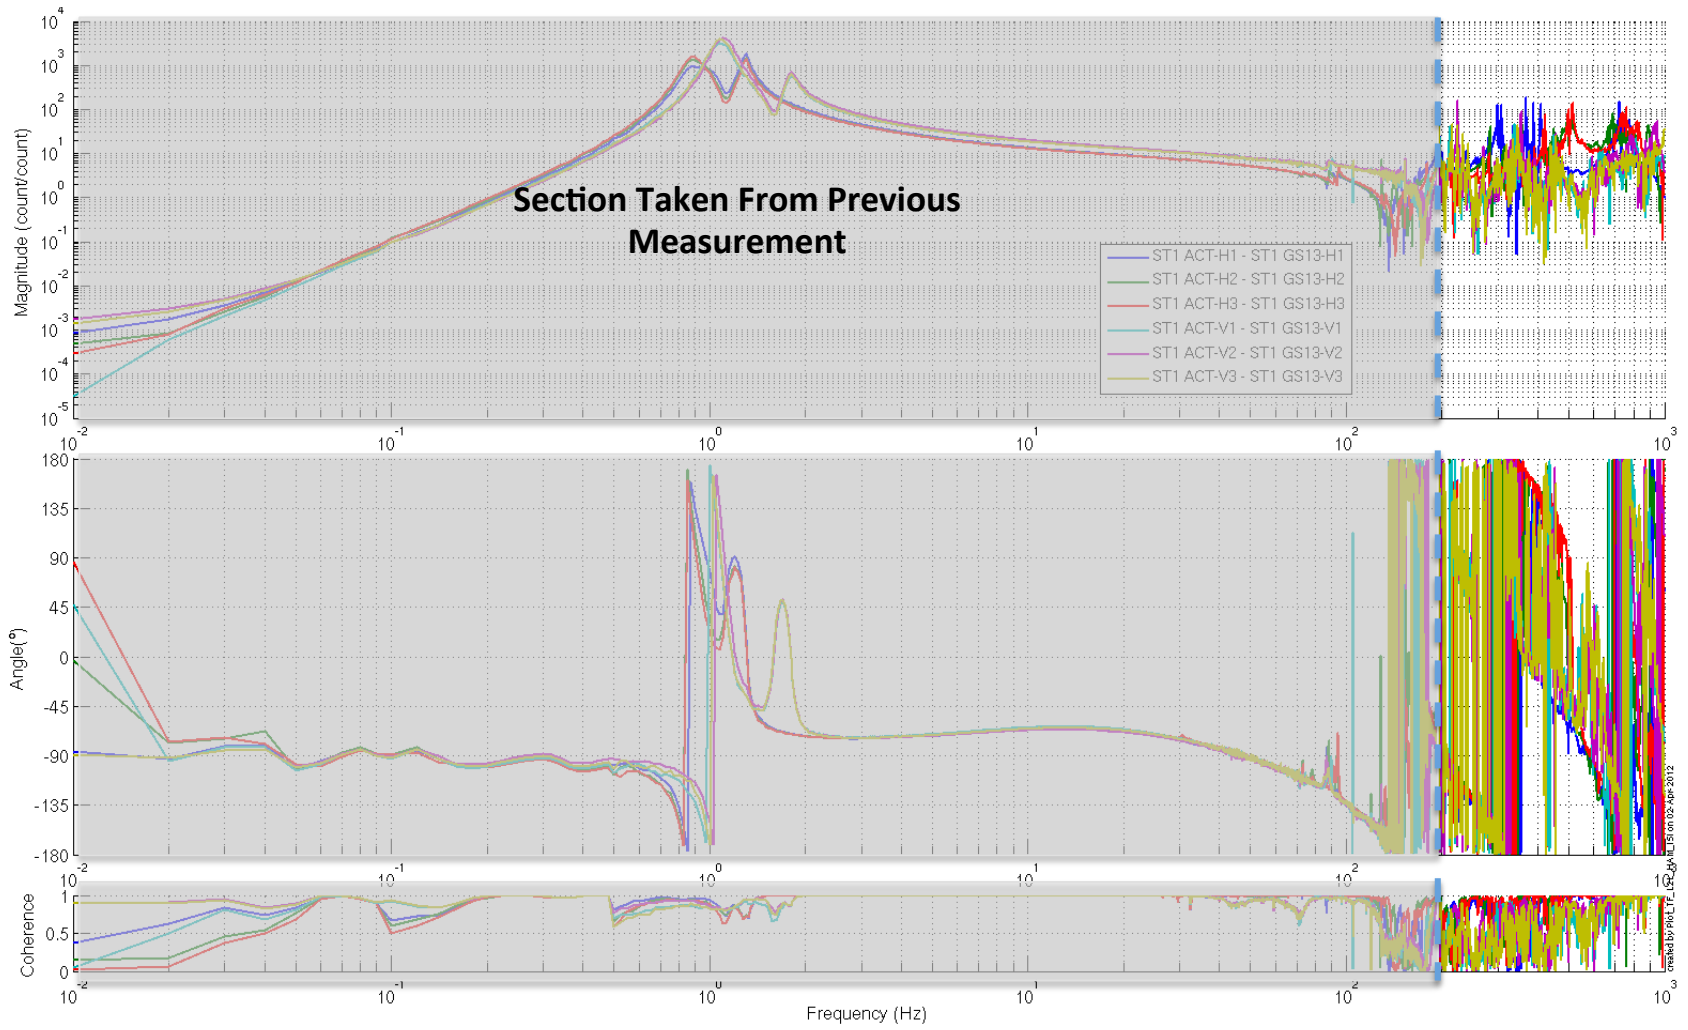
1 {Bolt + Washer} Found (And Removed) In The Vertical Hole Of The GS13 Door Of Corner #3

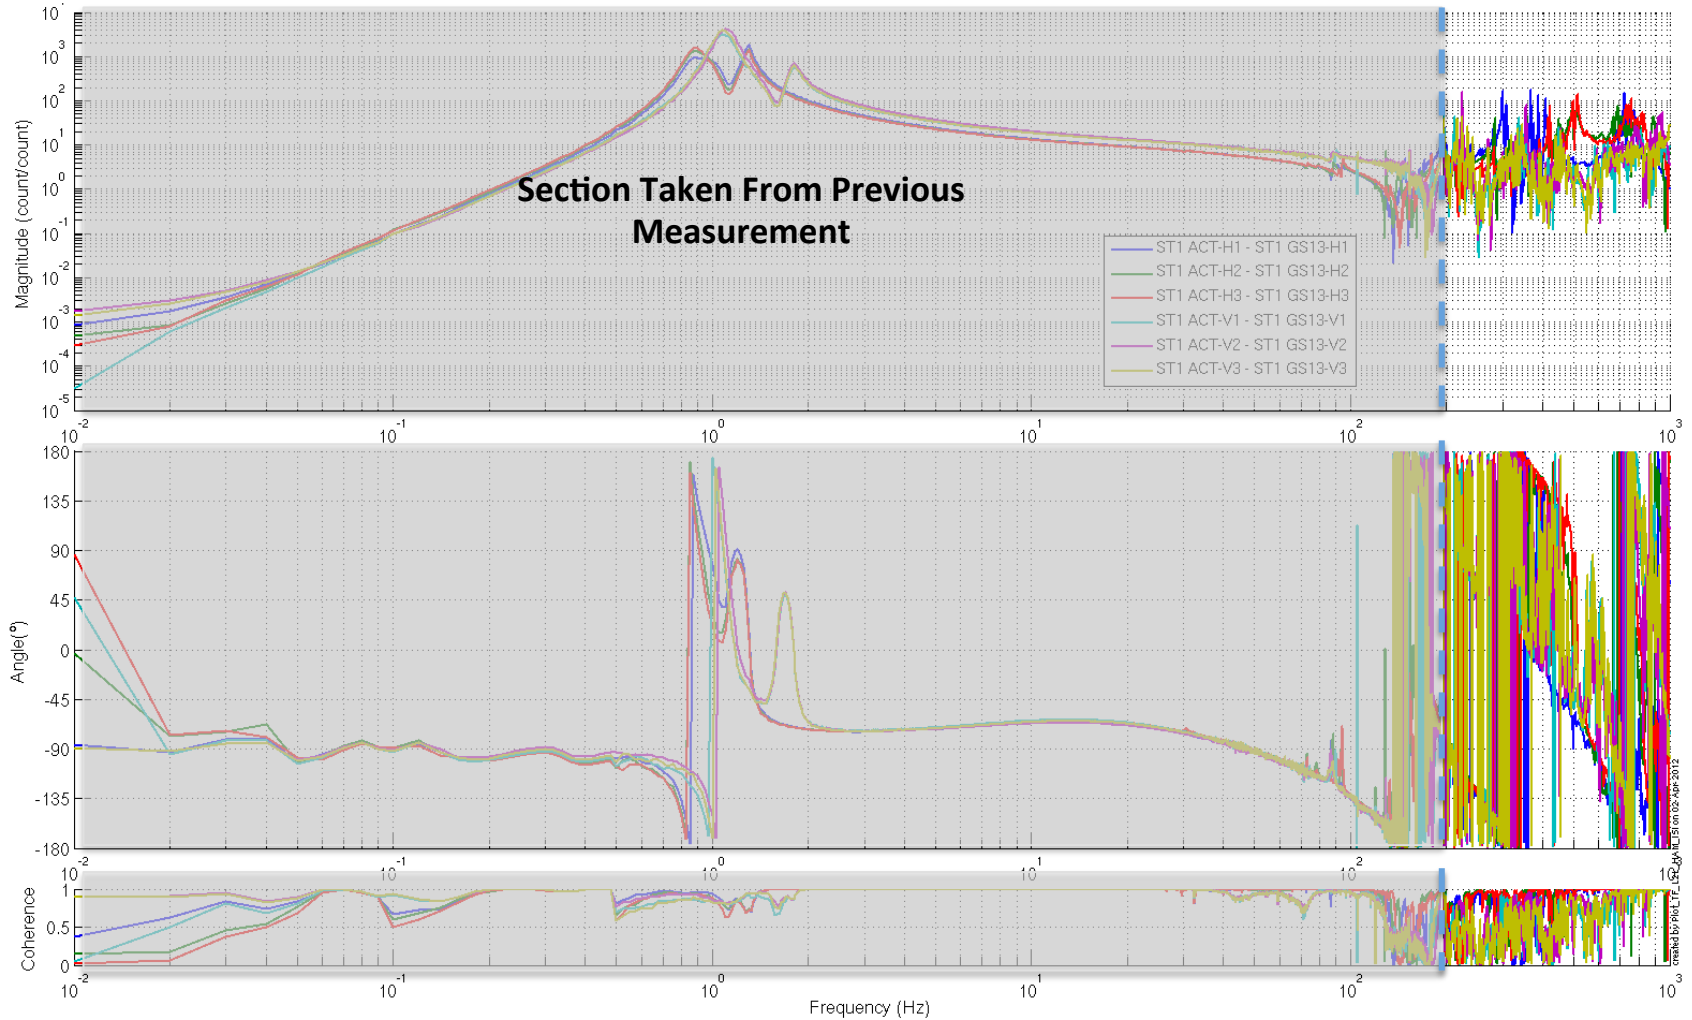
1 {Small Washer} Found (And Removed) On The Optical Table. Cable Of GS13-V3 Taken Away From Its Initial Position: Possibly Rubbing On Shielding Pigtail

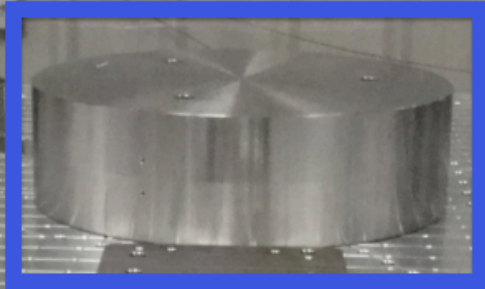
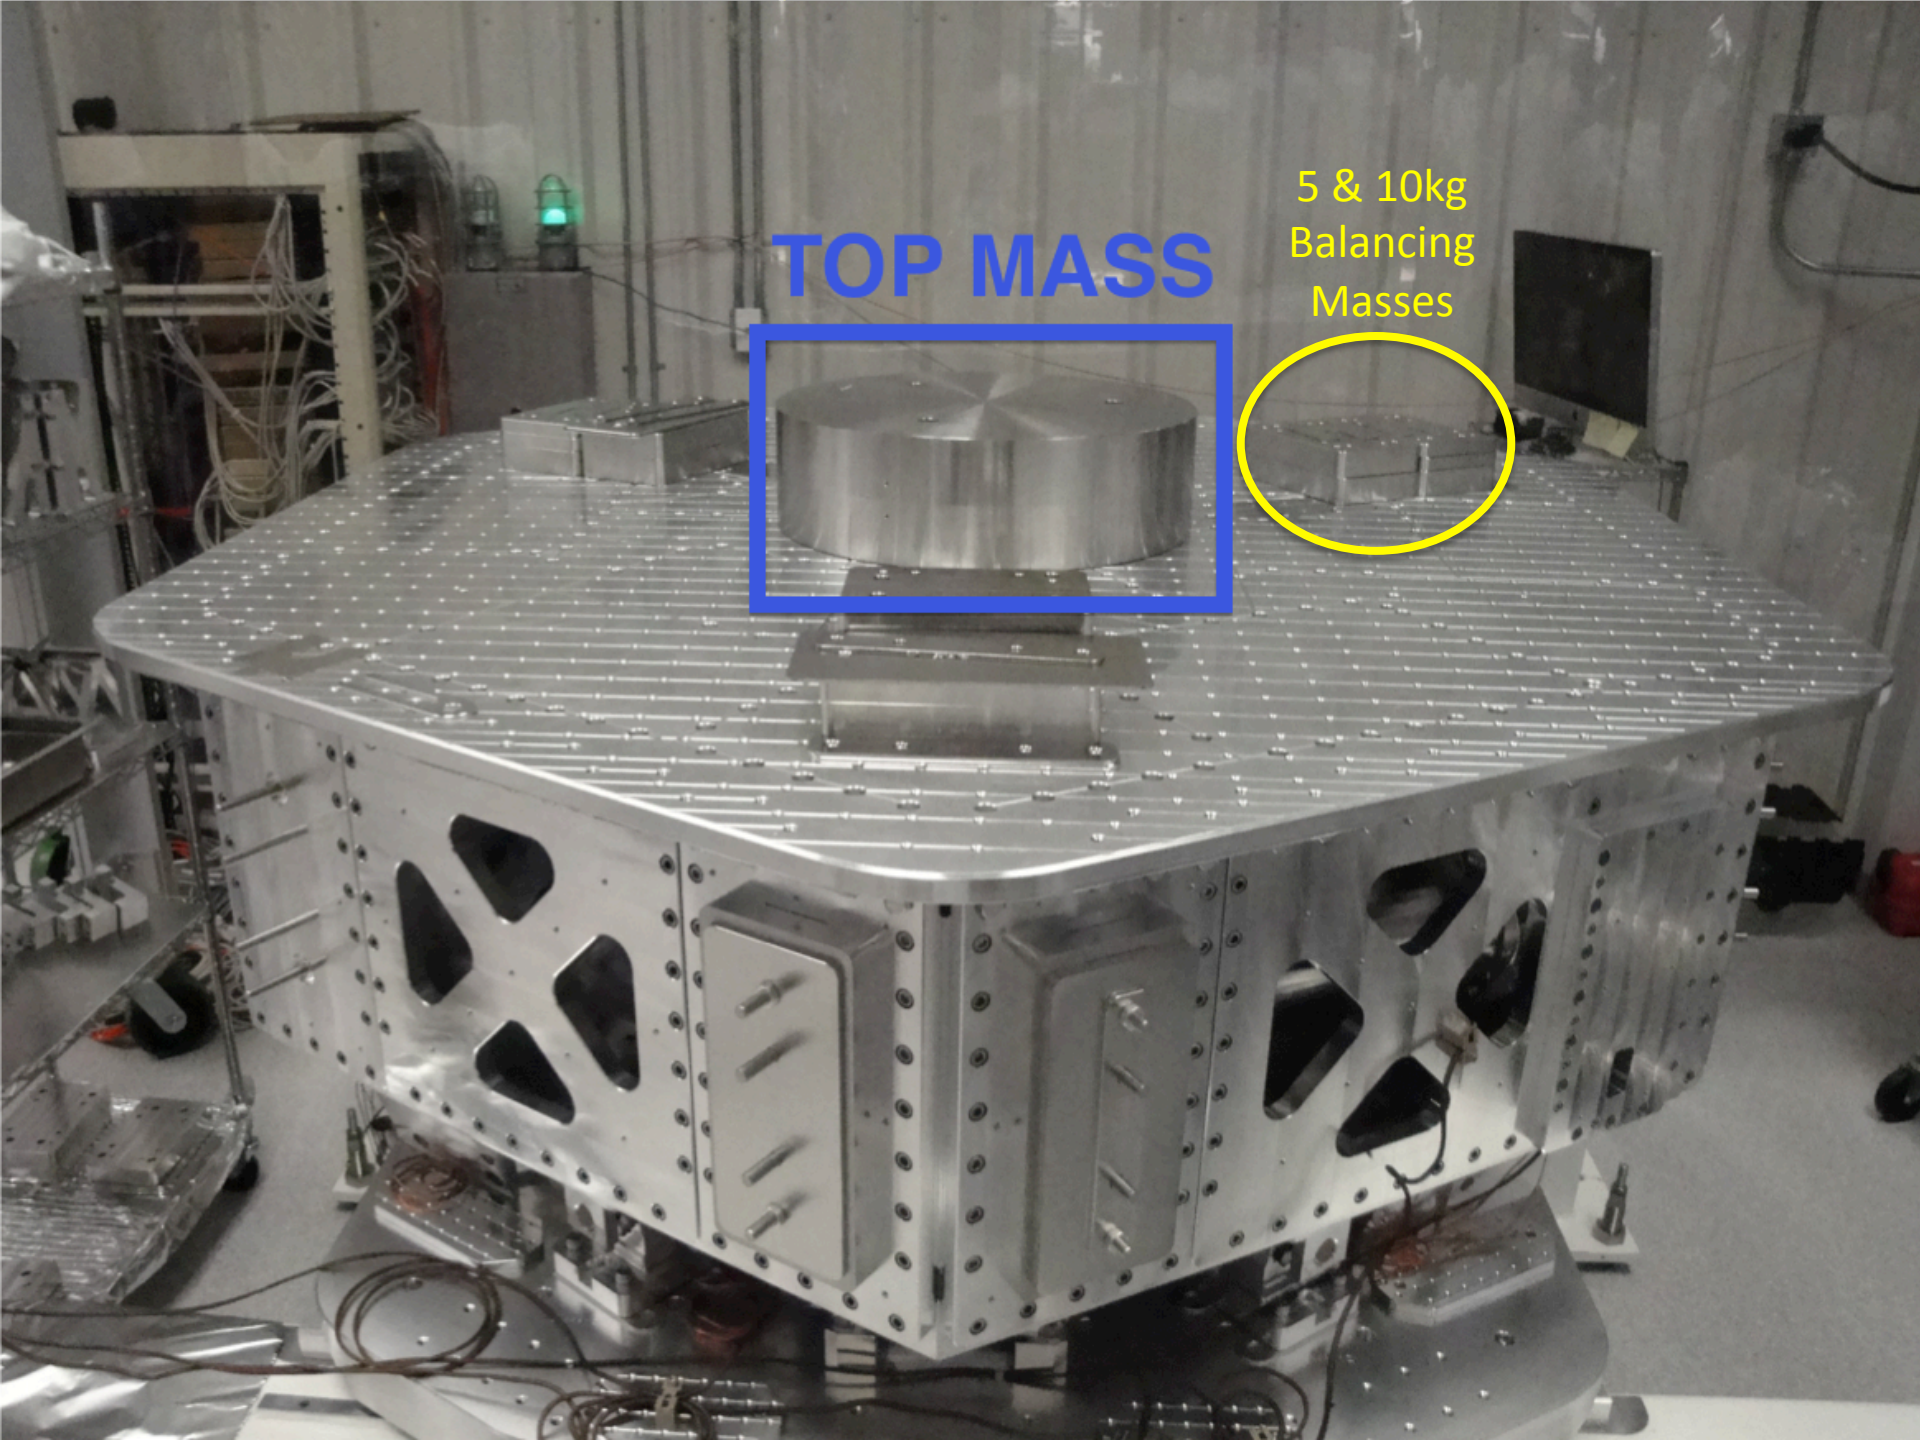
TOP MASS

5 & 10kg
Balancing
Masses
