## LHO BSC10 ICC 21 Feb 2013

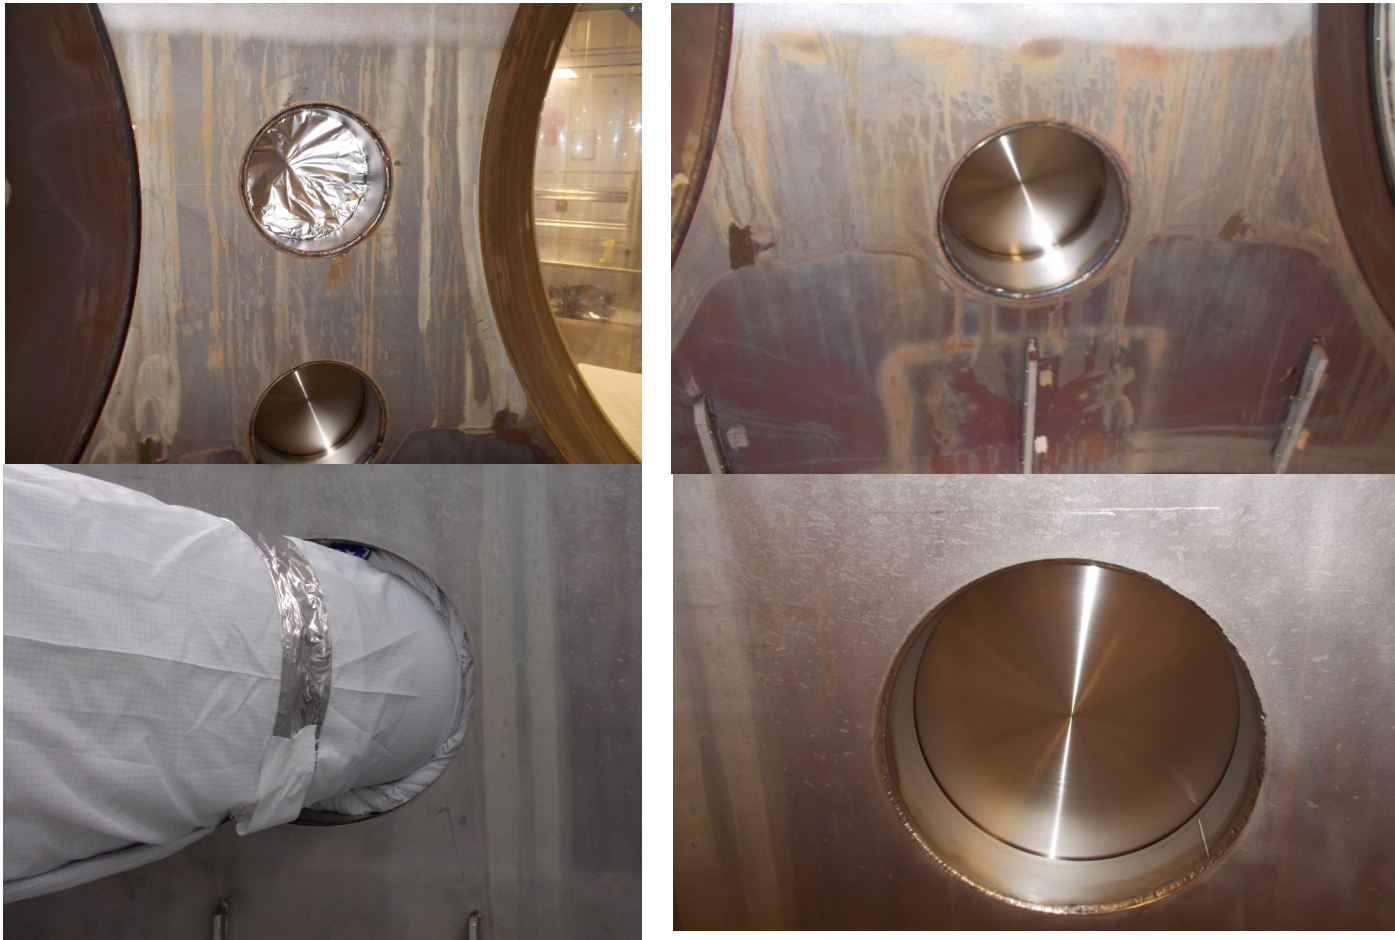
BSC10 has very robust color and staining from the original bake for strain relief. Note the deep brown/black background color, the yellow and orange trails and splotches and other colorful artifacts visible on the chamber's interior surface. (Upper photos) Some concern has been expressed with regard to the quality of the brushed sections. I inspected progress this morning and am satisfied that the ICC process is working as intended. Although the results are not as "pretty" or "shiny" as we would like, there is ample evidence that the surface layer is being removed (Lower photos). Notice the change in surface color to a silver/whitish background and the absence of orange and yellow trails.
