IR photos

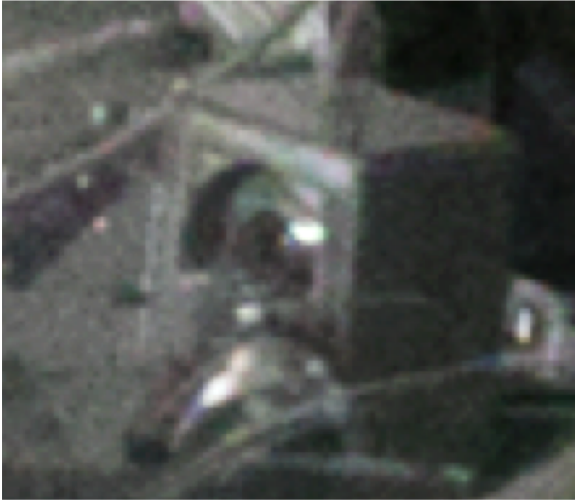
Alignment that maximizes current on PD, my guess is that the spot is a ghost beam – if it were the main beam it should be centered on PD

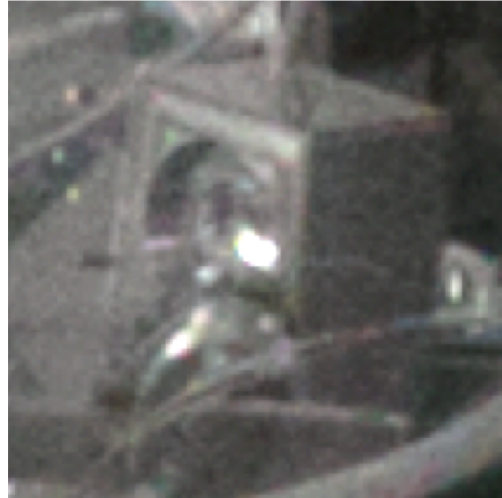
Pitch down to reduce current

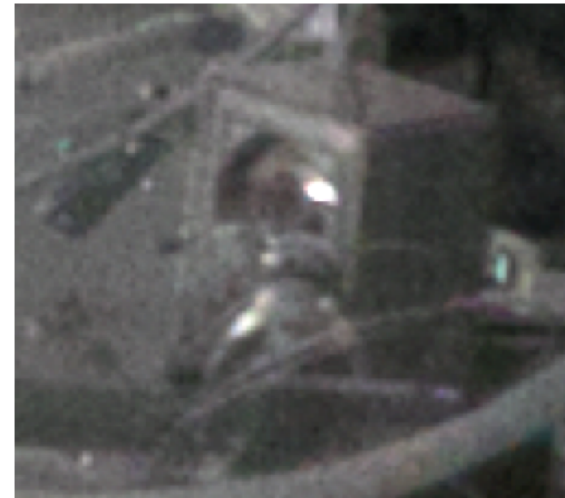
Pitched up higher than optimal with current matched to pitch down photo

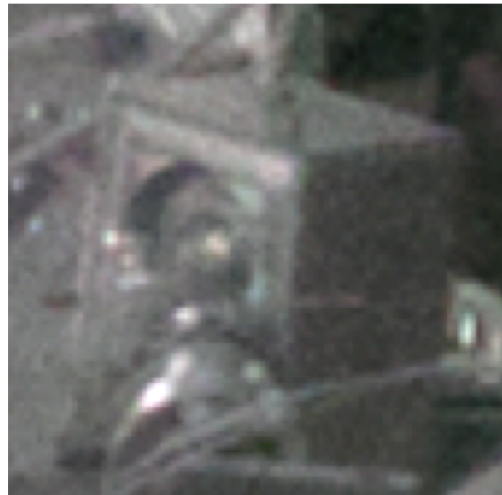
Yaw to left of optimal yaw, I think the ghost beam has dropped into the hidden side of the PD recess

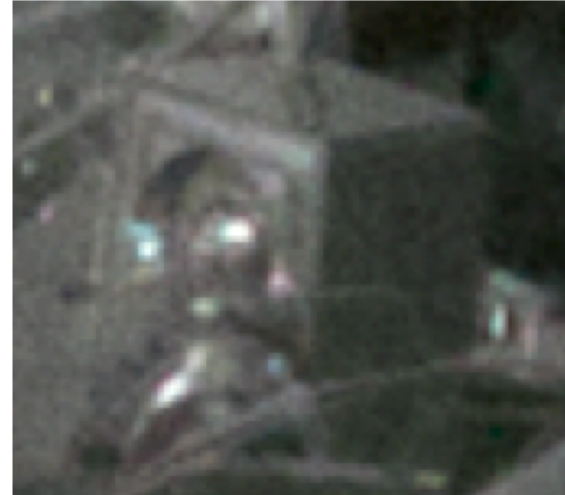
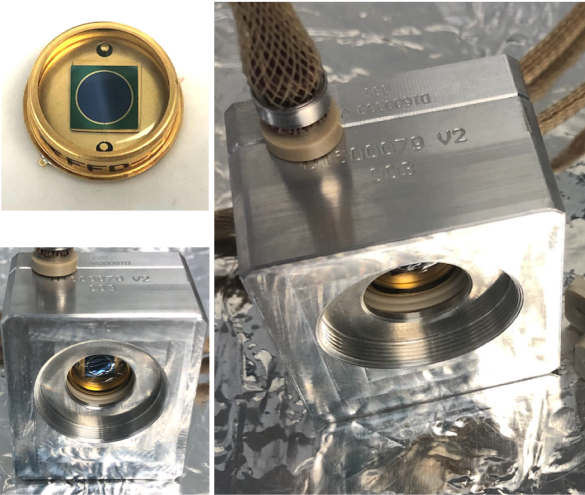
Yaw even further left, spot may be main beam starting to fall off diode. We lost lock before being able to yaw in the other direction
