T2200048-v3 - Grounding and short circuit check

K.Kawabe, edited by B.Weaver Feb 2022

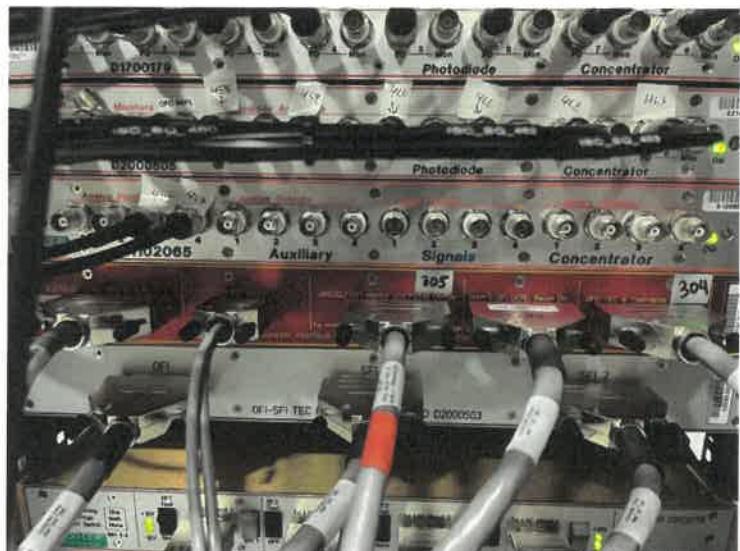
Diode A uses pin (18, 6, 19), diode B (4, 17, 5), C (15, 3, 16) and D (1, 14, 2).

- In addition to basic check, make sure that the DCPD sensor case is isolated from anode and cathode in chamber (no connection between 1-2, 1-14, 15-3, 15-16, 4-5, 4-17, 18-6 and 18-19).

Also check connection between different diodes. There shouldn't be any connection from any of e.g. Diode A pins to any of e.g. Diode B pins.
