# Issue History

Tuesday, June 27, 2017 17:07

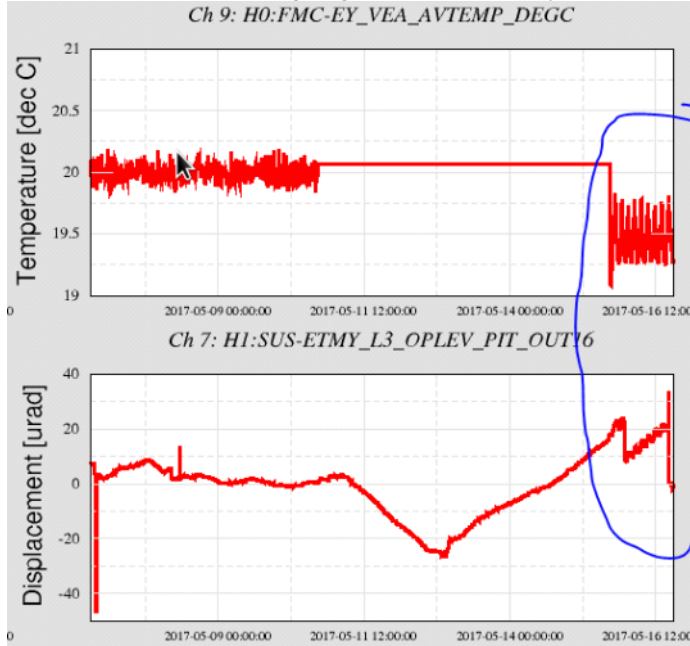
According to [aLOG 36208](#), the ETMY HVAC upgrades may have caused some sagging of the ETM and, therefore, a need to later change alignments once the temperature was stabilized

It also reports the first major change in Pcal PD outputs; per Jeff: "**Also note that PCAL Y sees a substantial effect of the large temperature excursions seen in the VEA during the upgrade as well, indicating that there is still some temperature sensitivity left in the system, like what was seen back in January (see, e.g. [LHO aLOG 34153](#)).**

**The gross clipping has gone away since the temperature has \*mostly\* recovered, but -- presumably because of the 0.5 deg C difference in static temperature, the RXPD is reporting 0.2% higher displacement than before the HVAC upgrade. Further, one can see the ~3 hour oscillation in the RX**

and TX PDs."
