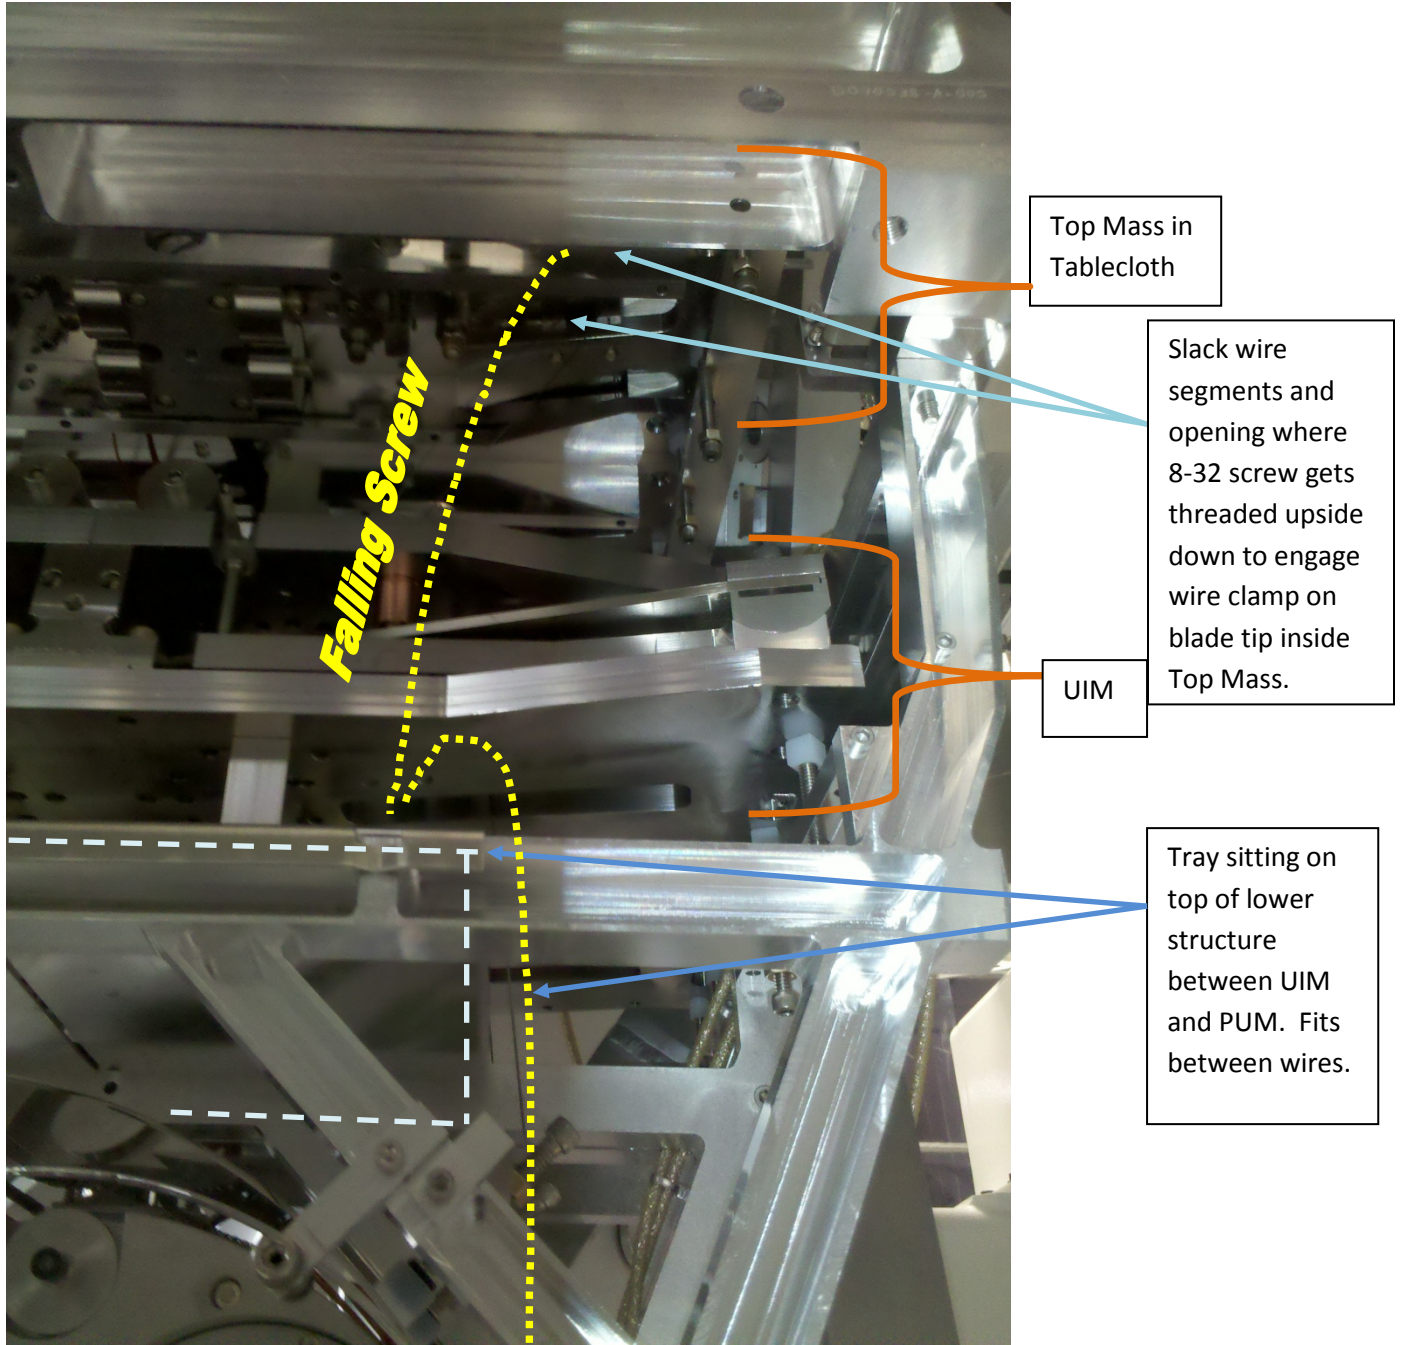
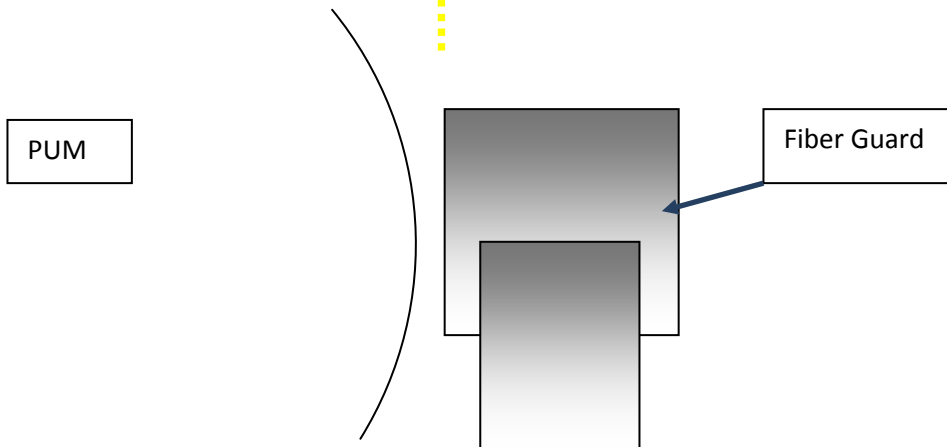
Fiber Guard – open on the inside so screw likely bounced down to top of test mass and then into fibers from the inside.

We're not sure how exactly it fell down to the test mass, possibly between the PUM and PenRe, or around the side of them and then bounced off the structure and back into the optic area.
