GS13 HUDDLE TESTING AFTER RECEPTION

Shipment #3523

destination: LHO HAM-ISI Unit #5

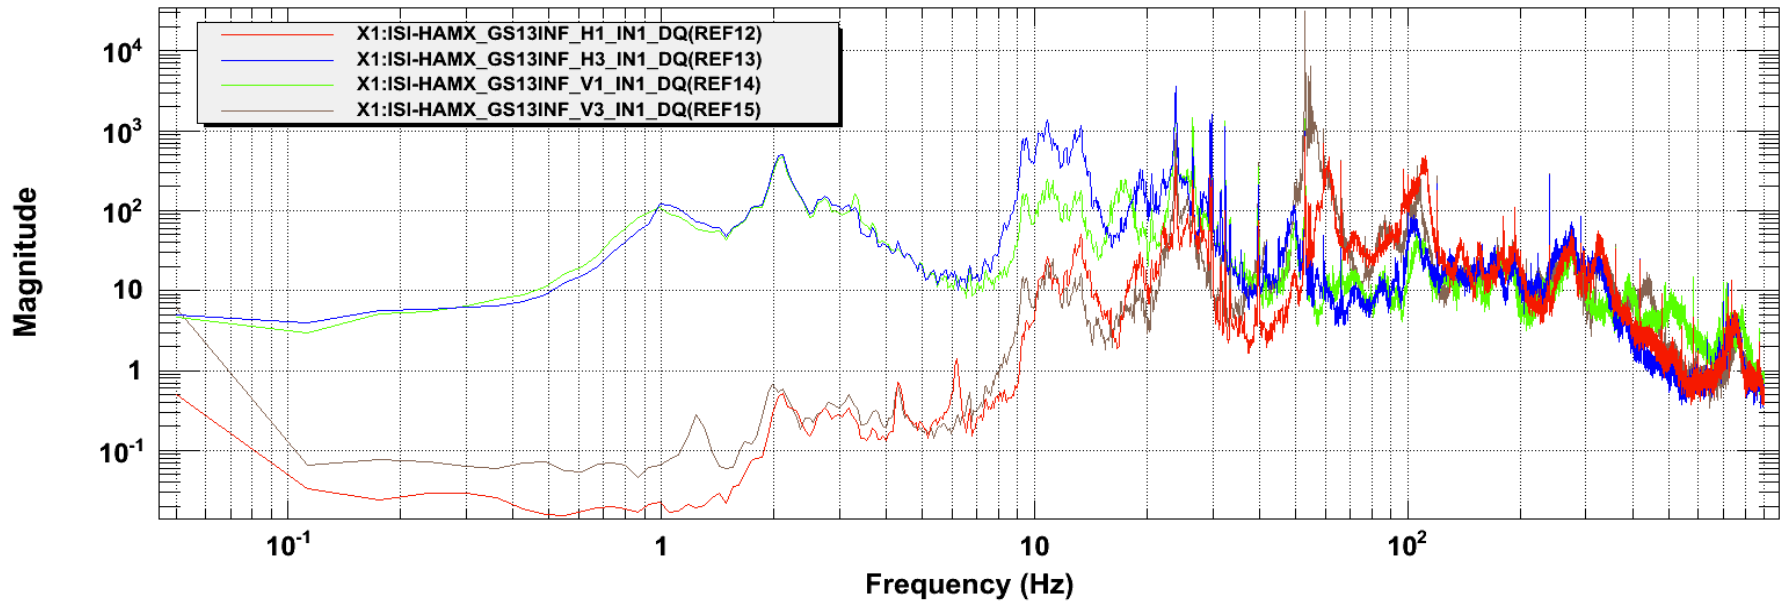
Horizontal GS13s Failure illustration

H1 - Pod #37 - 0°, as installed in ISI
H3 - Pod #20 - 0°, as installed in ISI
V1 - Pod #84 - 0°, as installed in ISI
V3 - Pod #27 - 0°, as installed in ISI

Note: Rotations are referenced from the diaphragm-side of the GS13s
