Figure 2a. H1 coupling time and amplitude consistent with septum, not HAM5/6 walls or ISI tables

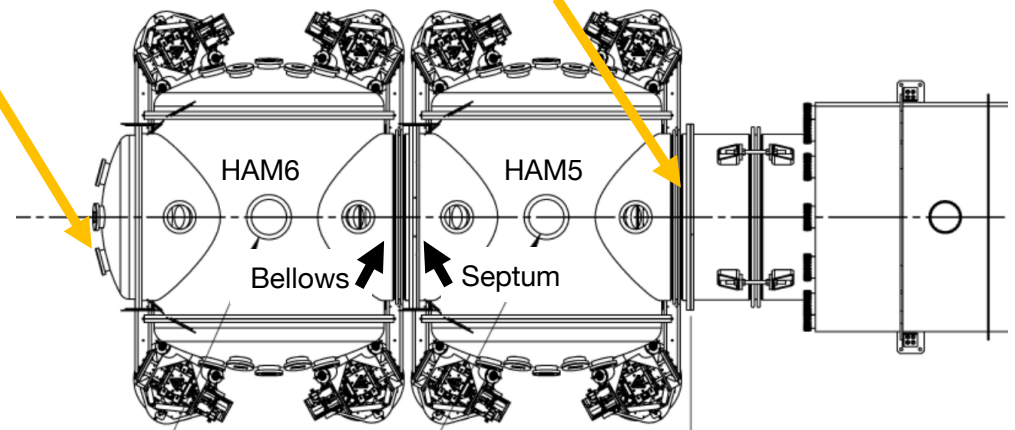
Pole strike on HAM6 end cap, 70 – 200 Hz band

Pole strike on HAM5 +Y flange, 70-200 Hz band

- 1 Blue HAM6 and red HAM5 accelerometers are not consistent in amplitude or time with effect in DARM
- 2 Septum accelerometer is more consistent in time and amplitude with DARM
- 3 Late arrival of signal on ISI GS13s indicates that the effect in DARM is associated with the vacuum enclosure, not motion of table.

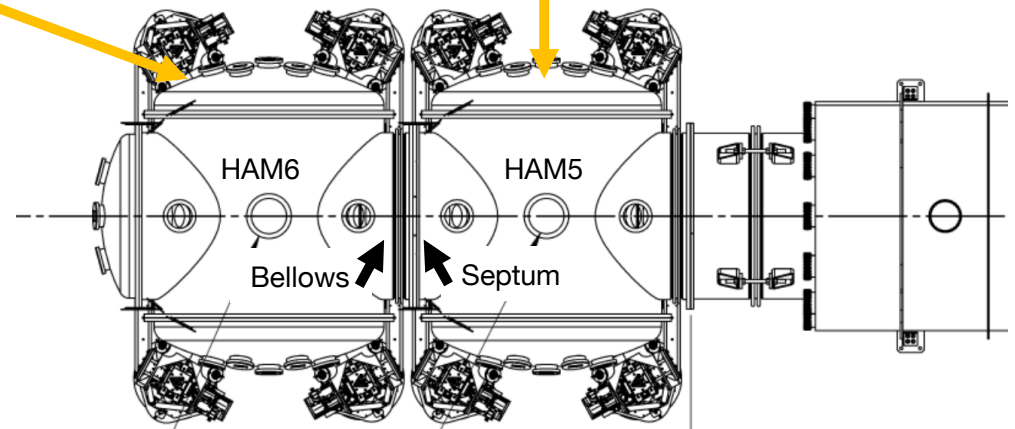
Figure 2b. H1 coupling time and amplitude consistent with septum, not HAM5/6 walls or ISI tables

Pole strike on HAM6 -X door, 70 – 200 Hz band

Pole strike on HAM5 -X door, 70-200 Hz band

- 1 Blue HAM 6, and red HAM5 accelerometers are not consistent in amplitude or time with effect in DARM.
- 2 Septum accelerometer is more consistent in time and amplitude with DARM
- 3 Late arrival of signal on ISI GS13s indicates that the effect in DARM is associated with the vacuum enclosure, not motion of table.
