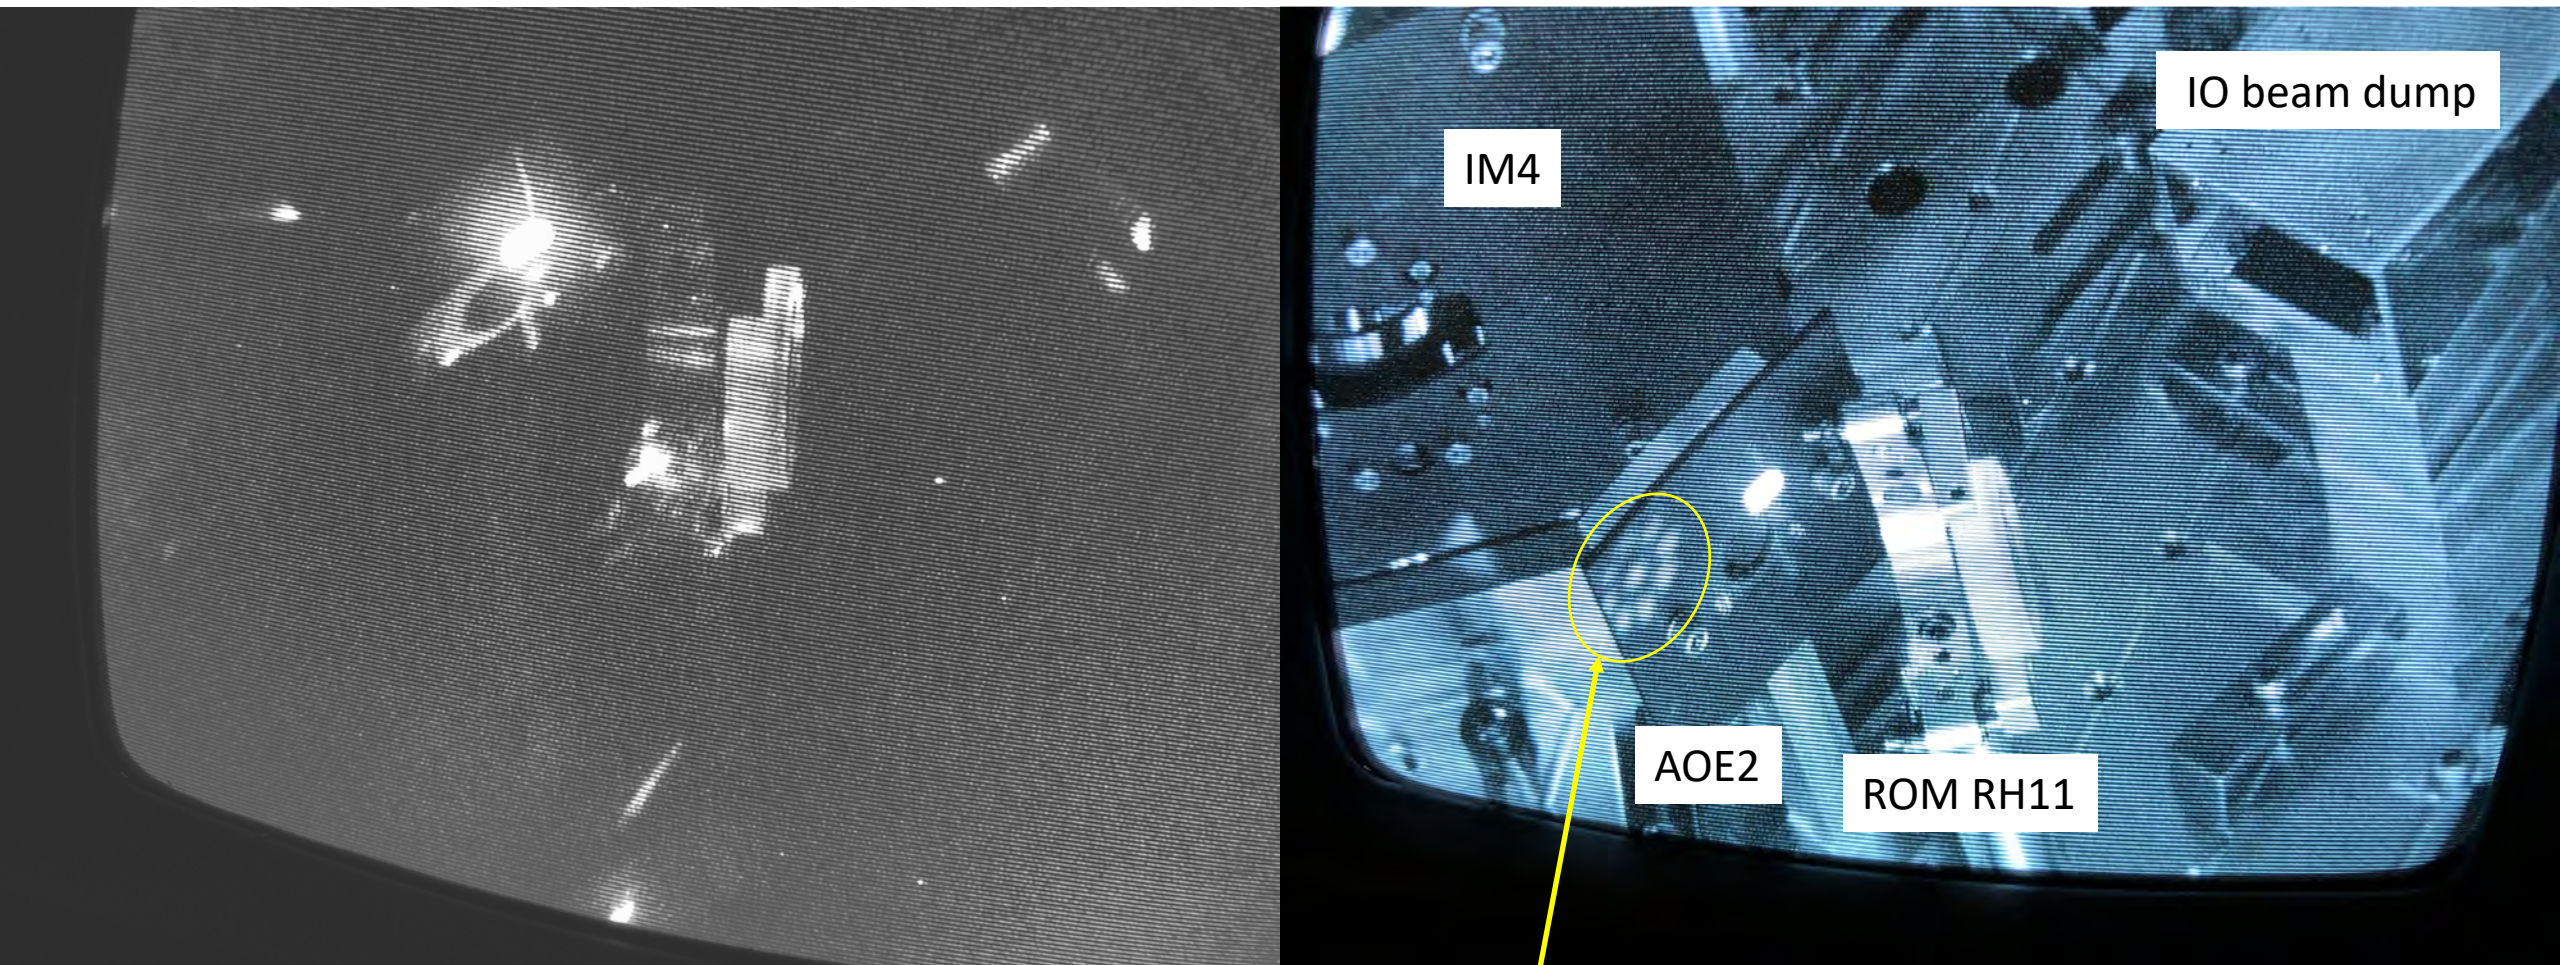
I believe this pattern is either visible light, or a product of PRM being misaligned during this image. However, the Forward Rejected Beam is missing ROM RH11 in this image, as it is in the IR images.
