Beam parameter incident on OMC M1 surface

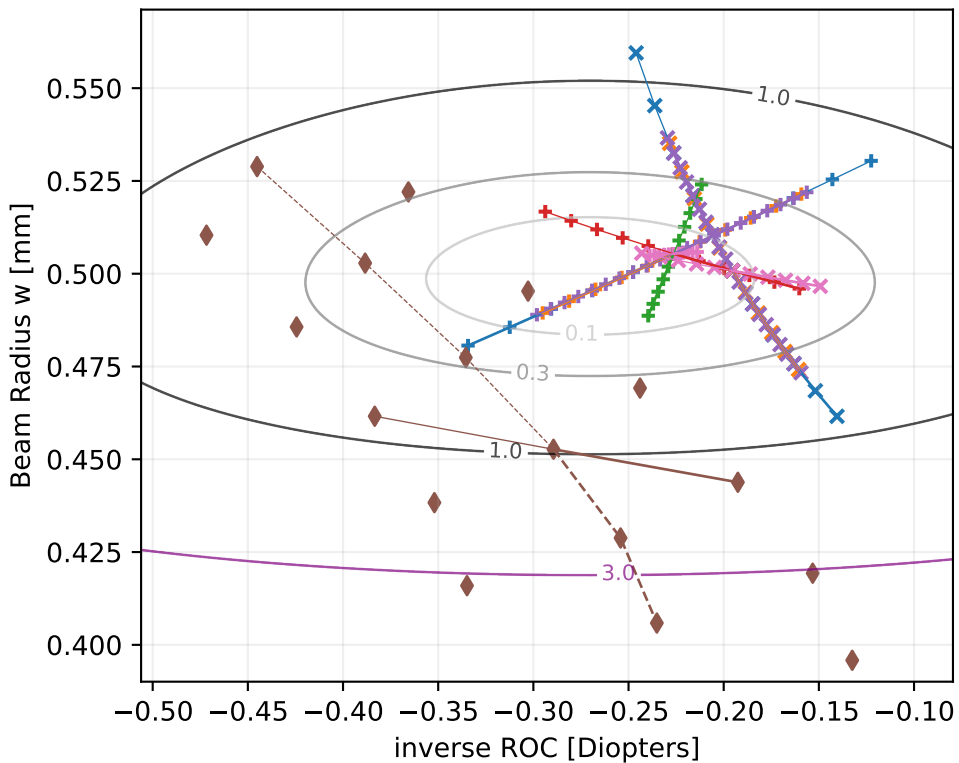
Beam Parameter Plot [X]

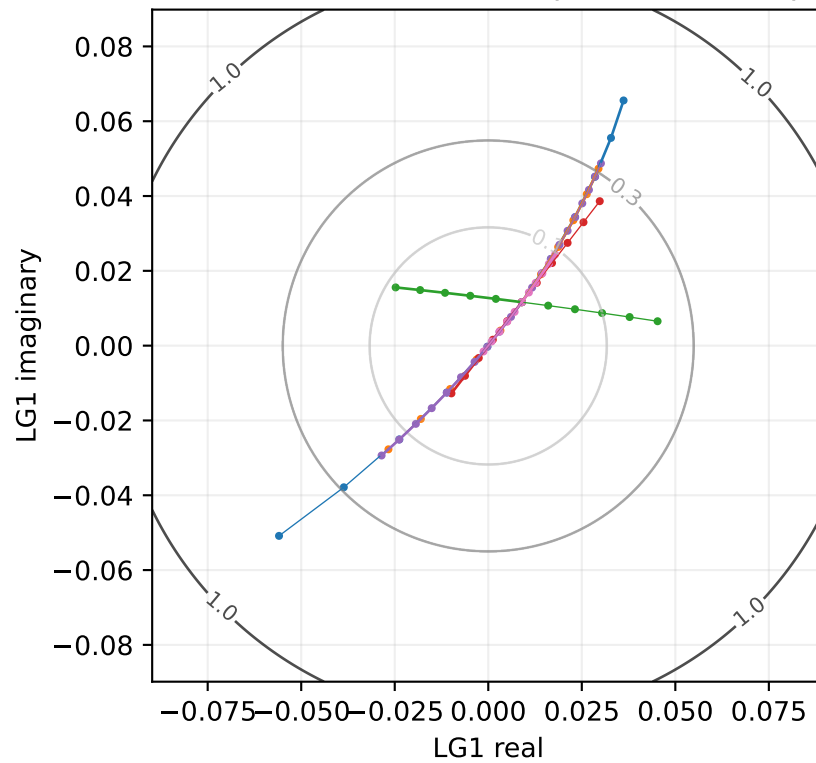
Rel. mismatch LG0->LG1 (X parameter coupling)

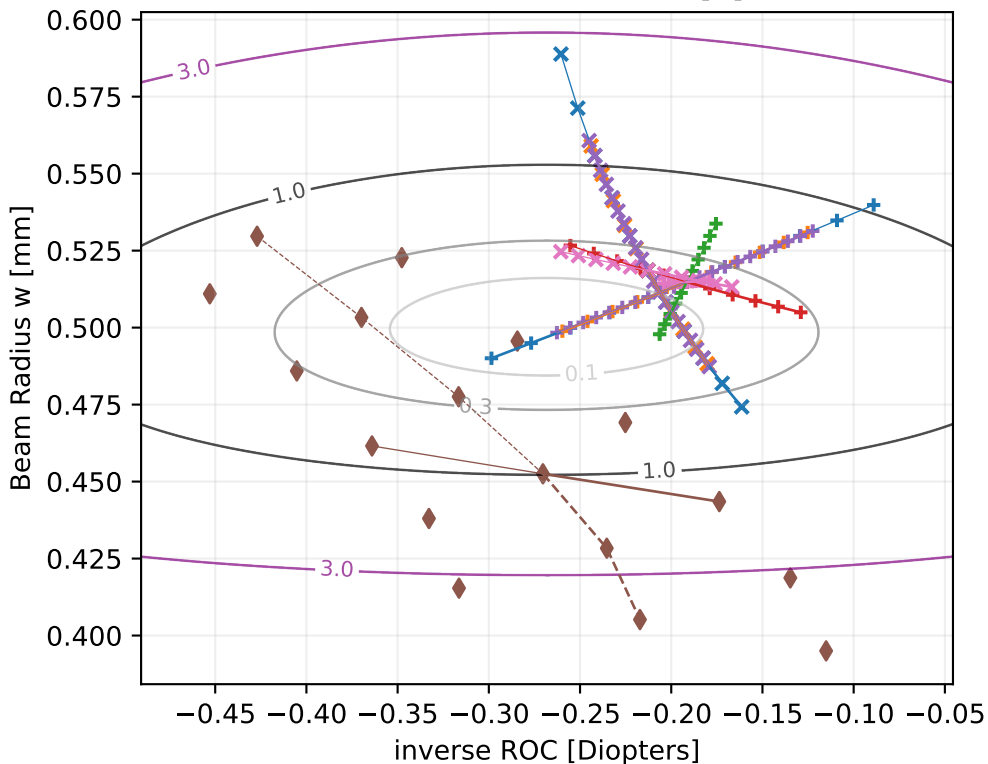
Beam Parameter Plot [Y]

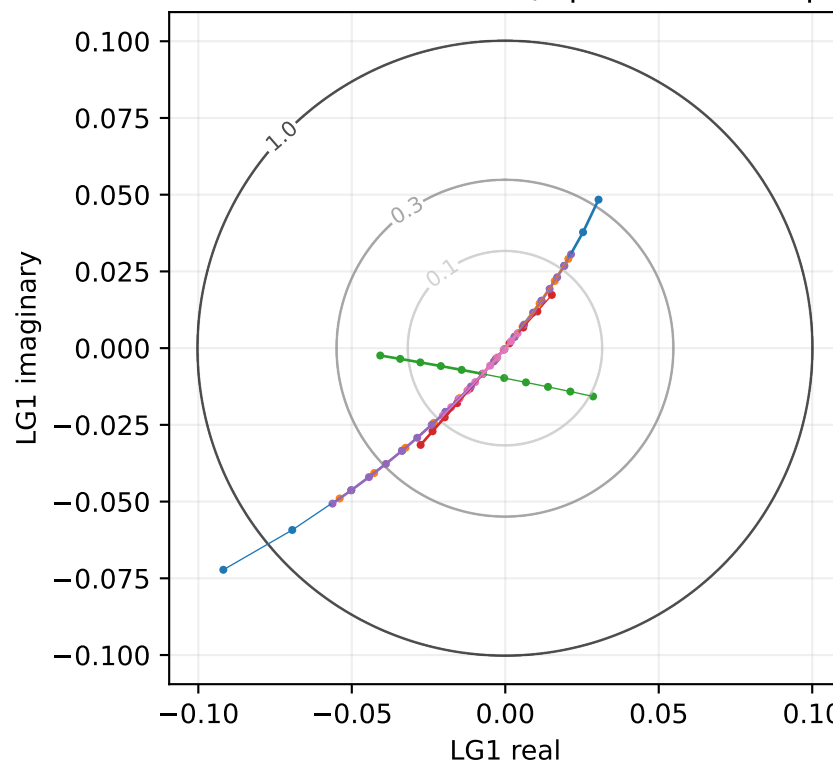
Rel. mismatch LG0->LG1 (Y parameter coupling)
